# SPH and City Slopes

# Slope Failure Potential

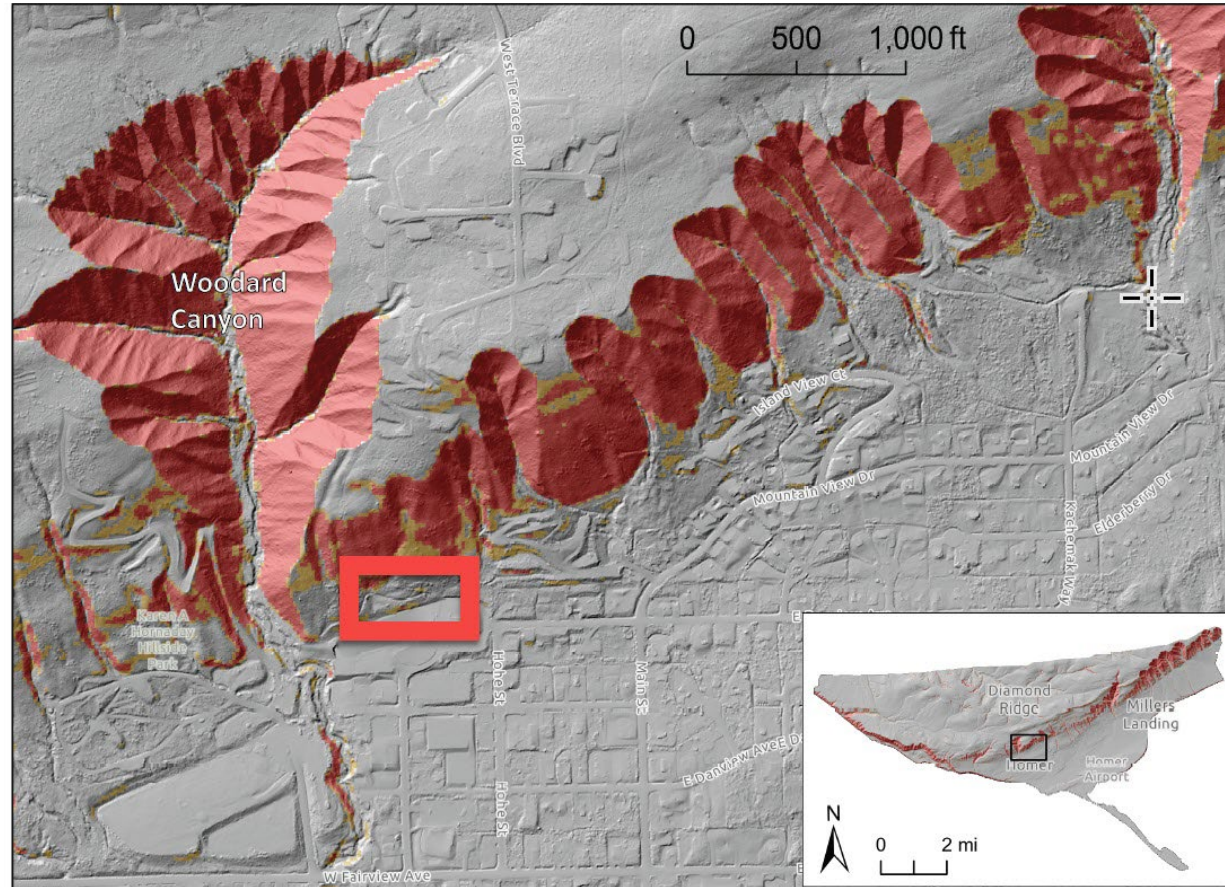
**Figure 7.** Excerpt from the Factor of Safety map (map sheet 2) highlighting areas of moderate (FOS 1.25–1.5, orange) and high (FOS 1–1.25, red) shallow landslide susceptibility at saturated conditions for the area near Woodard Canyon.

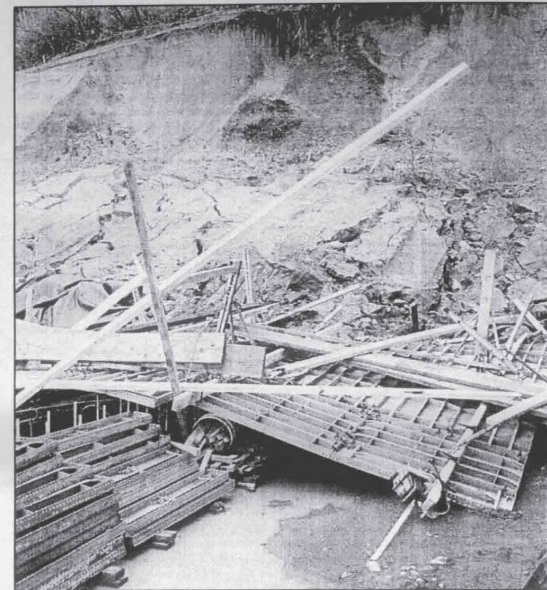
According to the National Weather Service, 1.28 inches of rain fell between 4 a.m. Saturday and 4 a.m. Monday. Homer's rainfall is measured at the airport, and weather service officials said it is possible more rain fell on the hillside where the hospital is located.

More than an inch of rain fell in several days leading up to Monday's slide, which appeared to be triggered by the saturation.

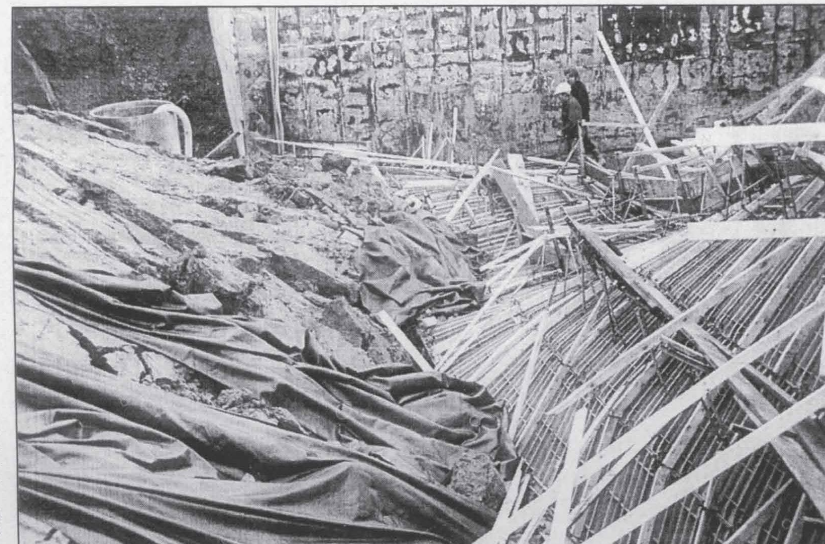
An estimated 100 cubic yards of wet clay and sand slid into the formwork, buckling the steel and breaking the wood.

On Wednesday, McLane said the group had decided to add an intermediate terrace to the cutbank, and use fill from the slide and the terrace project for fill in a swale adjacent to the west side of the addition. The topsoil will be removed from the swale later and replaced over the fill to promote revegetation, McLane said.

Crews will take three backhoes to the top of the slope above the slide and remove material in a relay to stabilize the bank, Keating said. Cushing and others surveyed a neighboring parcel of city-owned land as a possible site for the material that crews must remove from the slide area.
