ENVIRONMENTAL EVALUATION REPORT **72421 Milo Fritz Avenue, Anchor Point, Alaska**

ENVIRONMENTAL EVALUATION REPORT – PHOTO LOG
72421 Milo Fritz Avenue, Anchor Point, Alaska

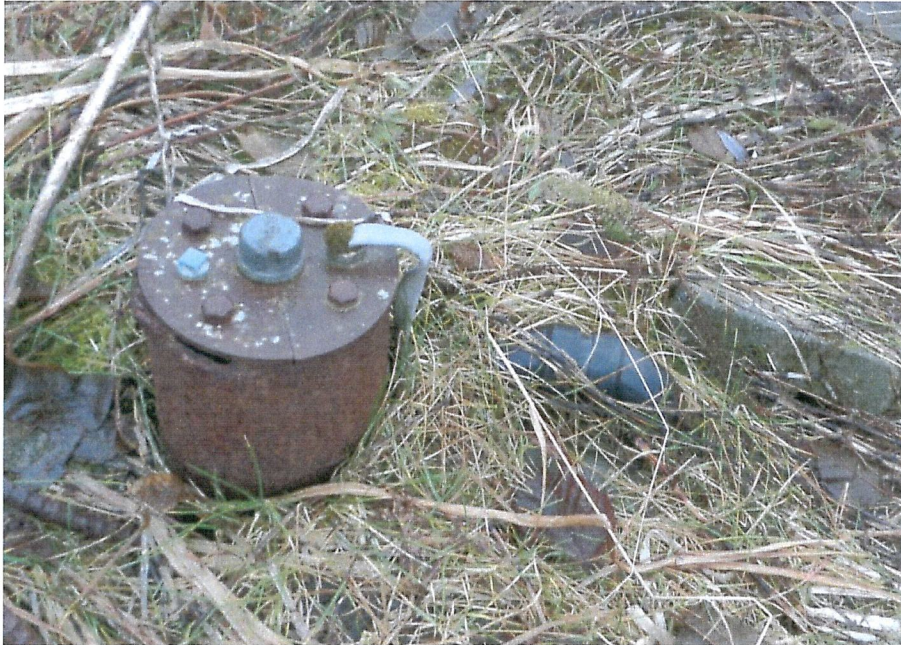
2. According to the Residential Disclosure Statement, the water supply for this home is an 80-foot deep well. The existing well is low to the ground, has poor drainage surrounding the wellhead and has a split-top plate style casing that is poorly-sealed with moss growing out of the electrical conduit opening. If this property is purchased and potable water is needed in the home, improvements are recommended to the wellhead, including: a) replacement of the split-top well cap with a properly sealed sanitary well cap and b) improved drainage to direct flow away from the well. If the well will no longer be used, it should be properly decommissioned; ADEC requires wells that are abandoned or not in use to be sealed, protected or filled. Note: A water valve (typical of the type of valves used on water service lines) was observed approximately 5 feet from the well (toward the Milo Fritz Avenue), but according to the disclosure statement, the water source for the home is the well.

Photo 1: Wellhead (in need of improvements if used as a potable source)

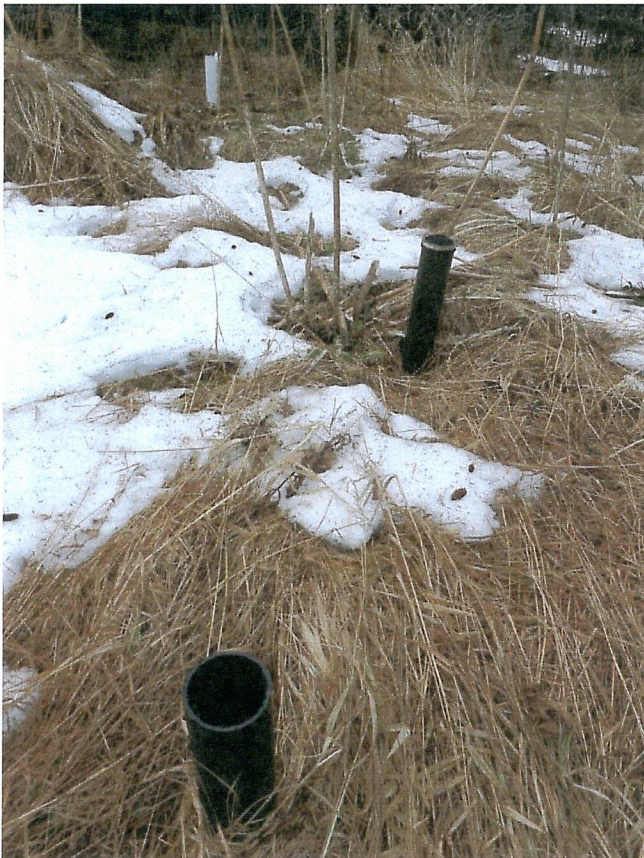
3. According to the Residential Disclosure Statement, the property has a septic tank and/or a holding tank, which is 30-40 years old. It appears that the tank is located approximately 60 feet southwest of the home. It is not clear if there is a soil absorption system on the property. A single broken riser (with a concrete base) was noted approximately 15 feet from the presumed septic tank at the head of a mound, which could potentially be a mounded soil absorption system (SAS). Two other apparent septic risers were visible to the west of the garage. Note: If the home is purchased, the septic/holding tank should be either removed or properly abandoned once it is no longer needed. Old, buried tanks present *serious hazards* due to cave-ins and collapses.

Photo 2: Septic Tank Risers (with missing caps)

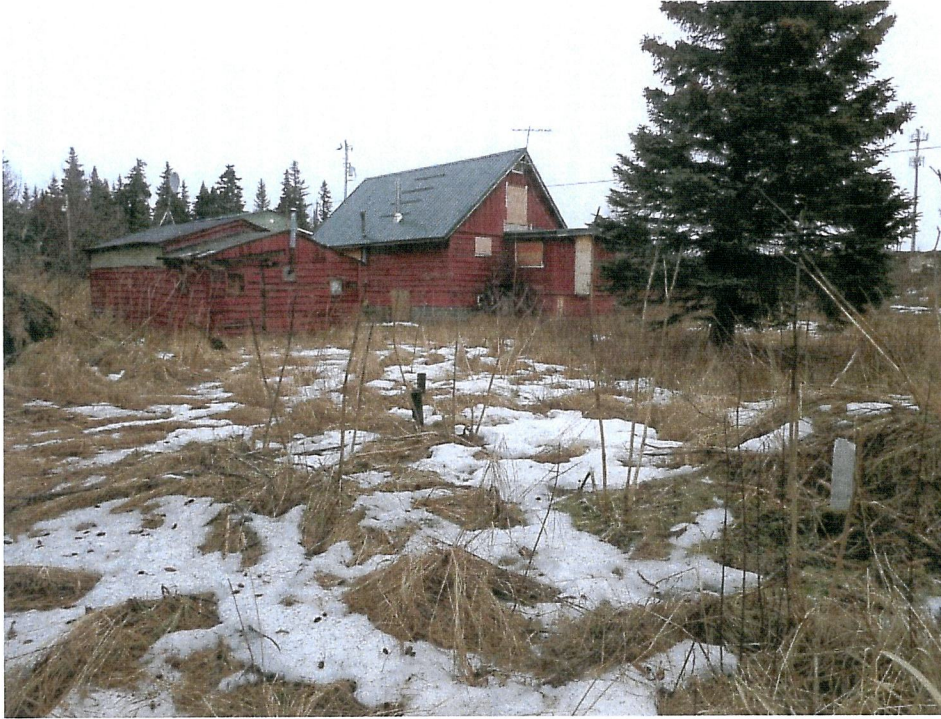
Photo 3: Septic Tank Risers (*center of photo*) and Broken Possible SAS Riser (*right side*)

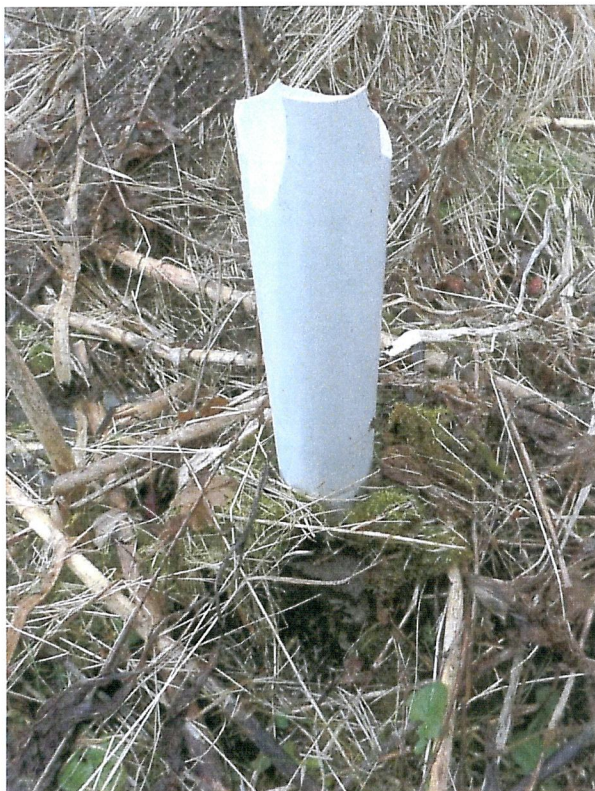
Photo 4: Broken Possible SAS Riser

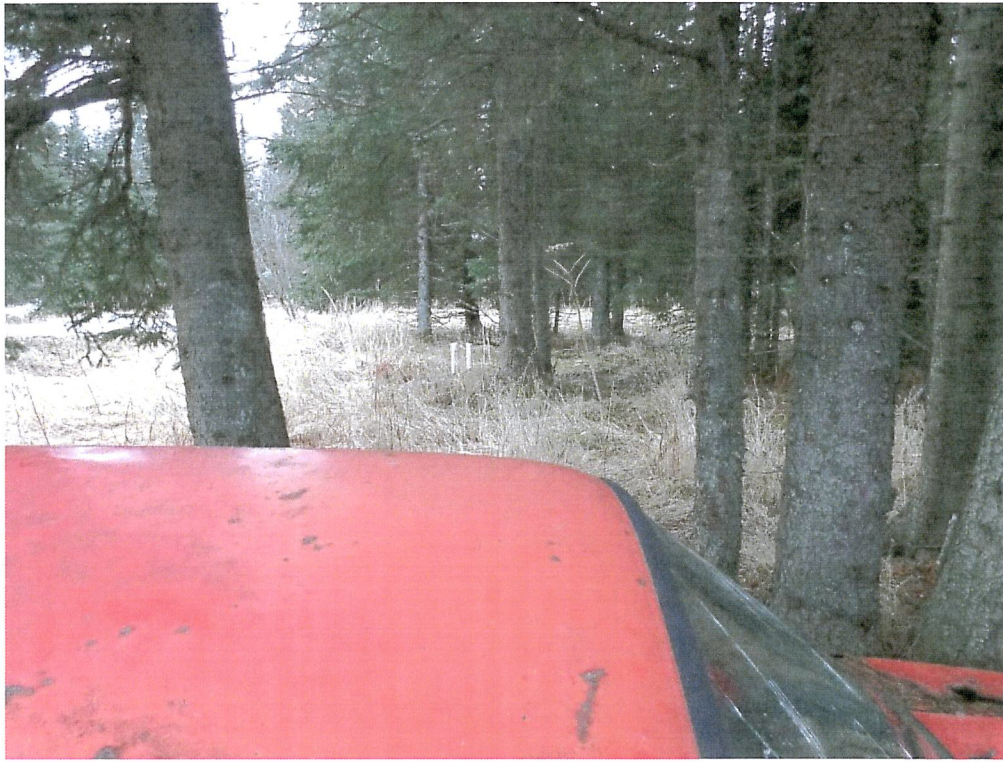
Photo 5: Additional possible SAS risers (*center of photo, in the distance*)

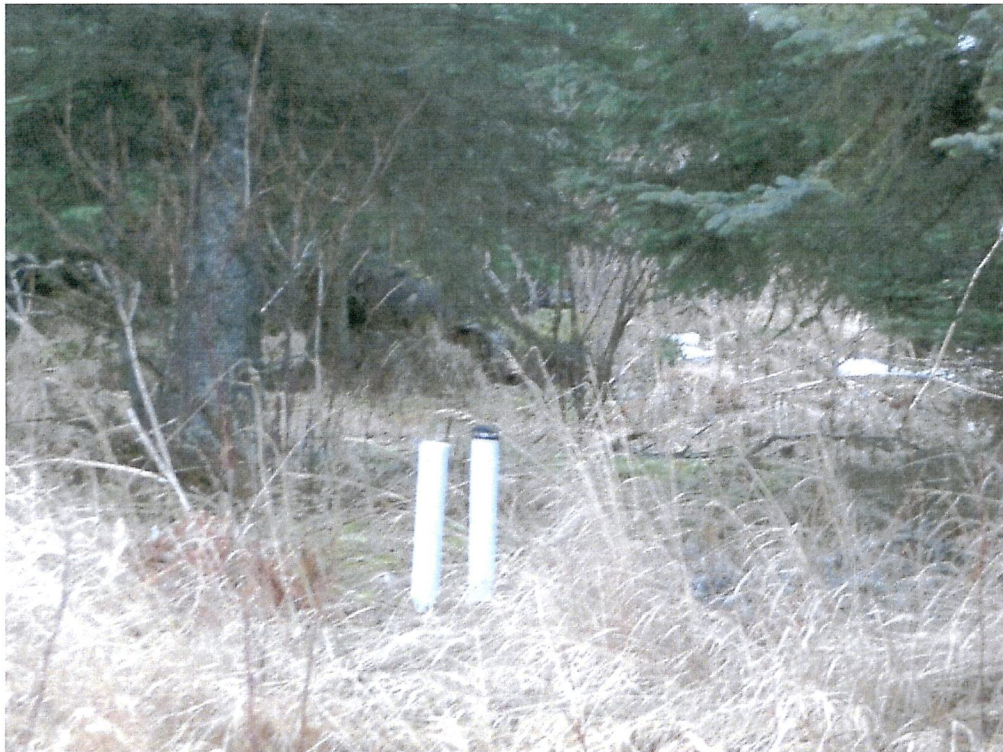
Photo 6: Additional possible SAS risers

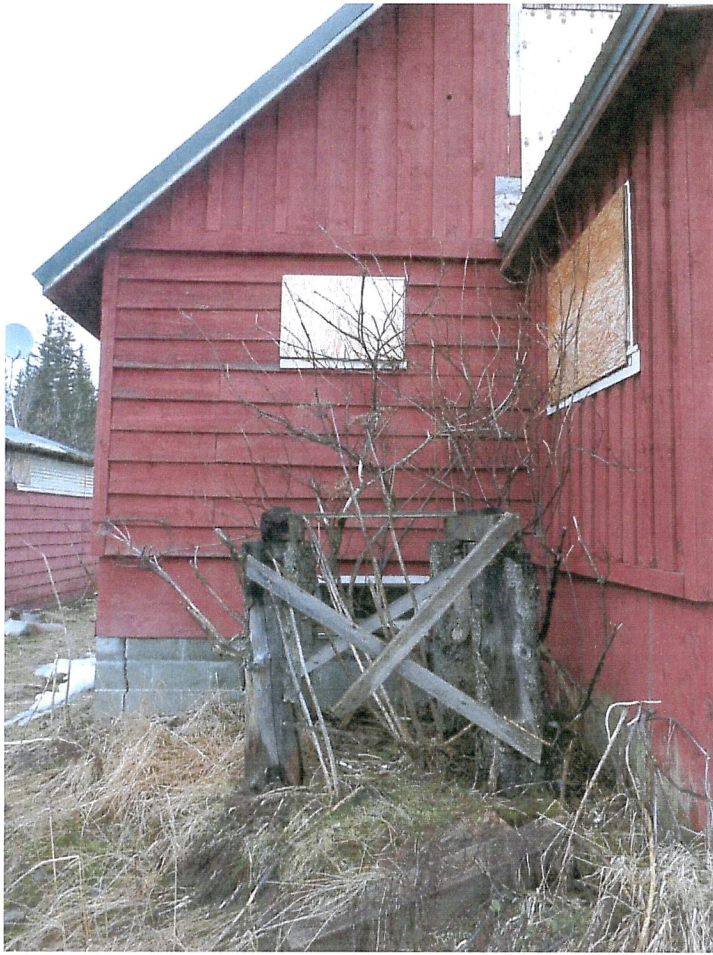
5. Based on the presence of an apparent fuel tank stand and nearby remnant fuel piping leading to two different points in the home, it appears a fuel tank was once present on the backside of the home. No fuel odors or visible staining or sheens were observed.

Photo 7: Fuel Tank Stand on Backside of House

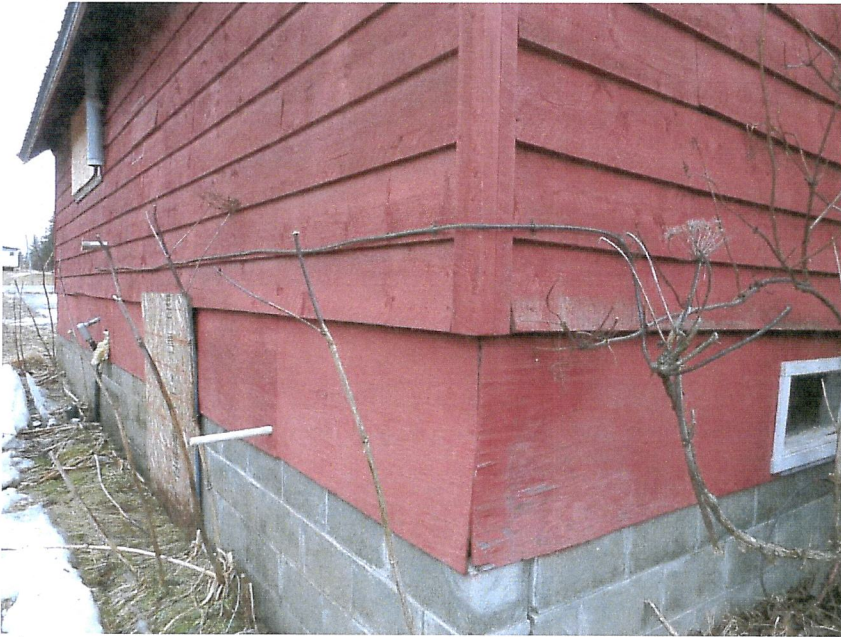
Photo 8: One of the Two Fuel Lines

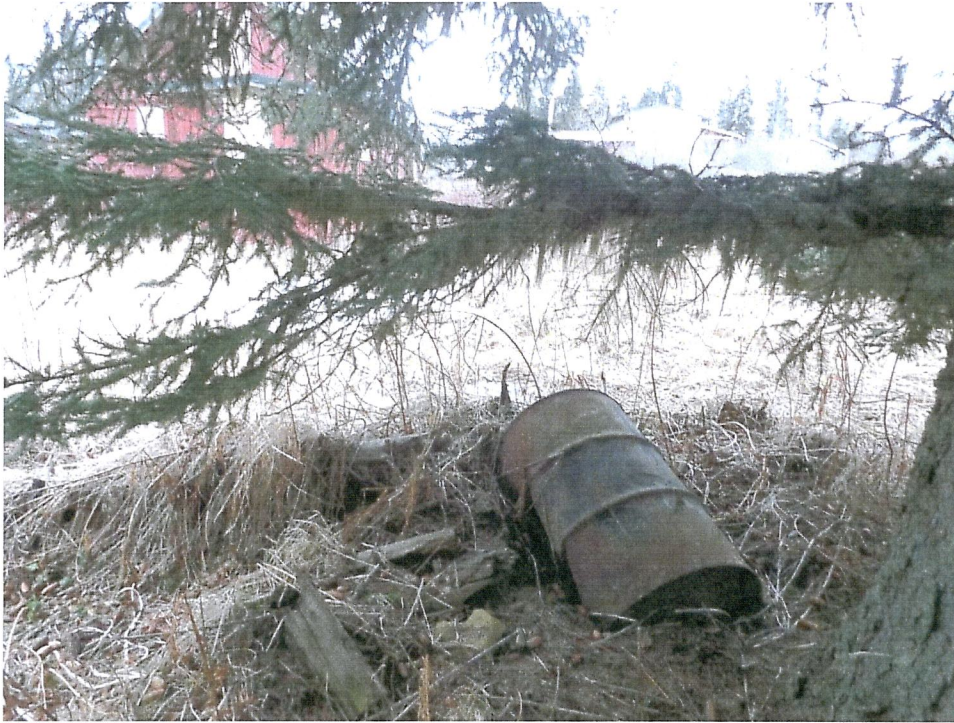
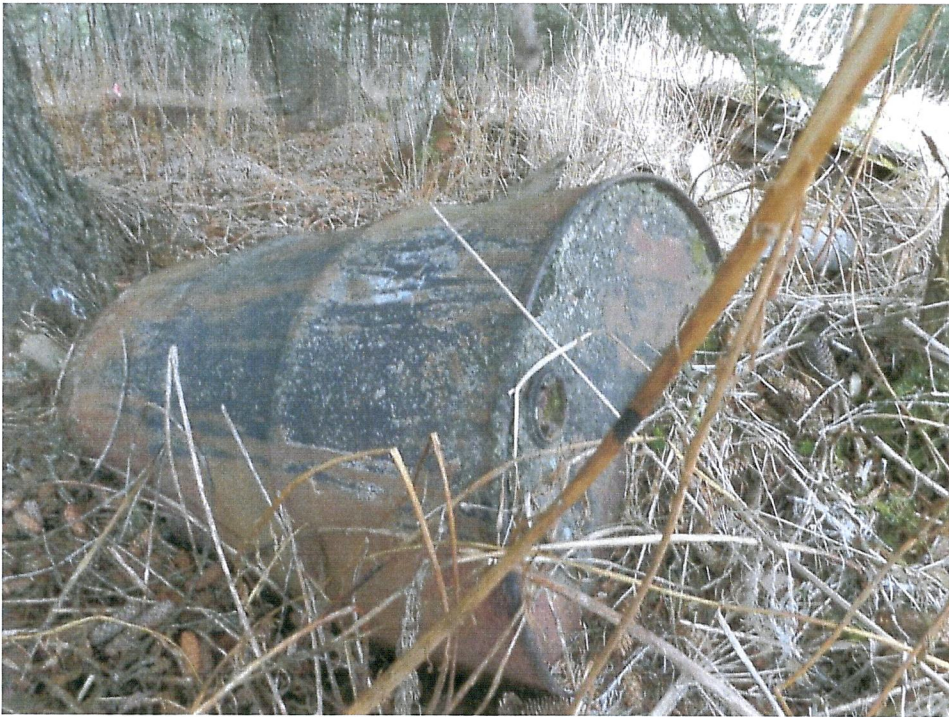
6. A rusty, dented, closed-top 55-gallon drum was observed in the southeast corner of the property near the Church Circle right-of-way cul-de-sac. The drum was lying on its side, with the bung closed and it was partially sunk into a small mound of dirt and debris. The drum did not appear to be empty, but the contents are not known. The drum and its contents should be properly disposed of using a qualified waste handler. The waste handler may require testing of the contents of the drum prior to disposal.

Photo 9: 55-gallon Drum

Photo 10: 55-gallon Drum

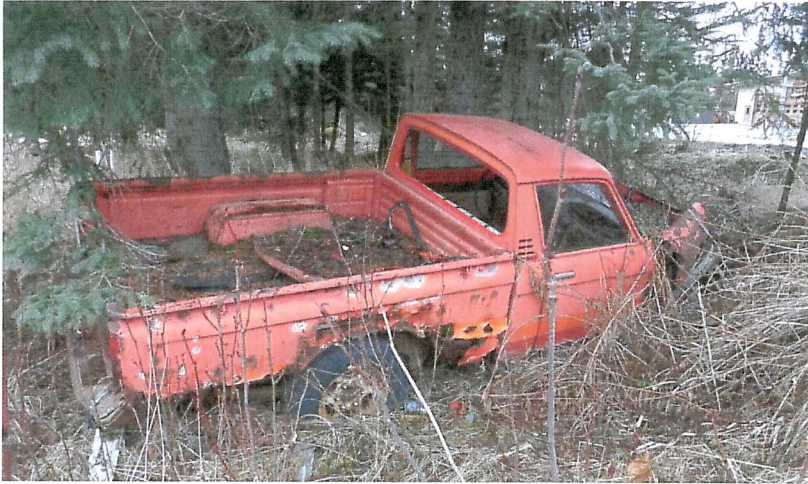
7. A dilapidated vehicle (without an engine) was observed northwest of the garage, and a vehicle engine was observed to the northeast of the home (in or near the Church Circle right-of-way). No staining was observed, but there is potential for soil contamination beneath the vehicle and engine.

Photo 11: Dilapidated Vehicle

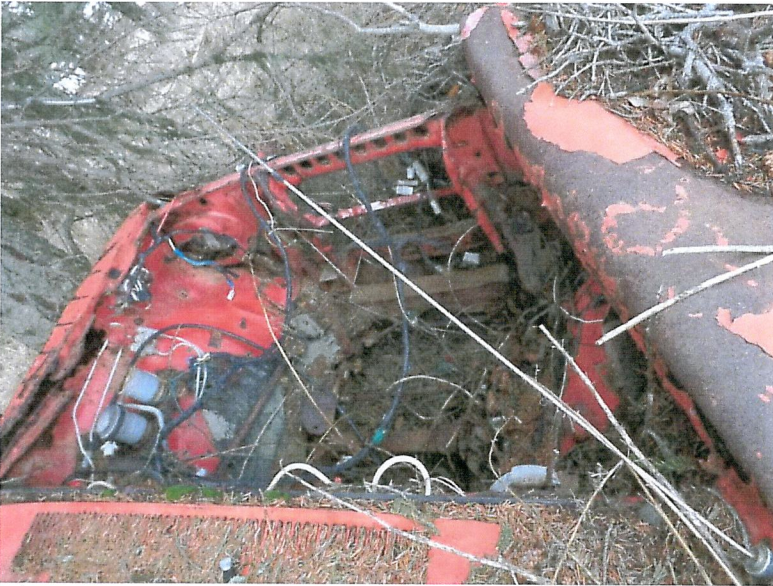
Photo 12: Engine Compartment of Dilapidated Vehicle (with engine missing)

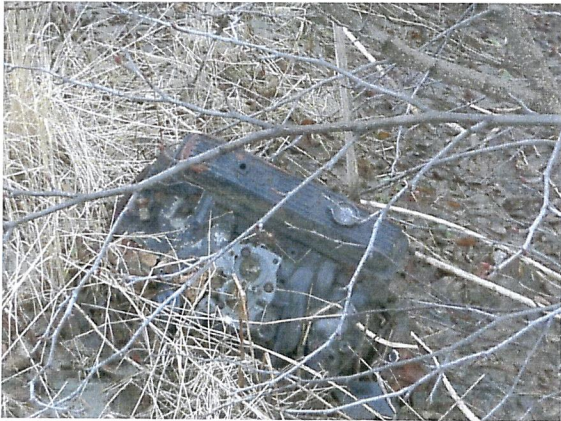
Photo 13: Vehicle Engine Found In or Near Church Circle Right-of-Way
