### **Capital Projects Department**

### **BUILDING INSPECTION REPORT RESIDENCE LOCATED AT: 72421 MILO FRITZ AVE., ANCHOR POINT, AK 99556**

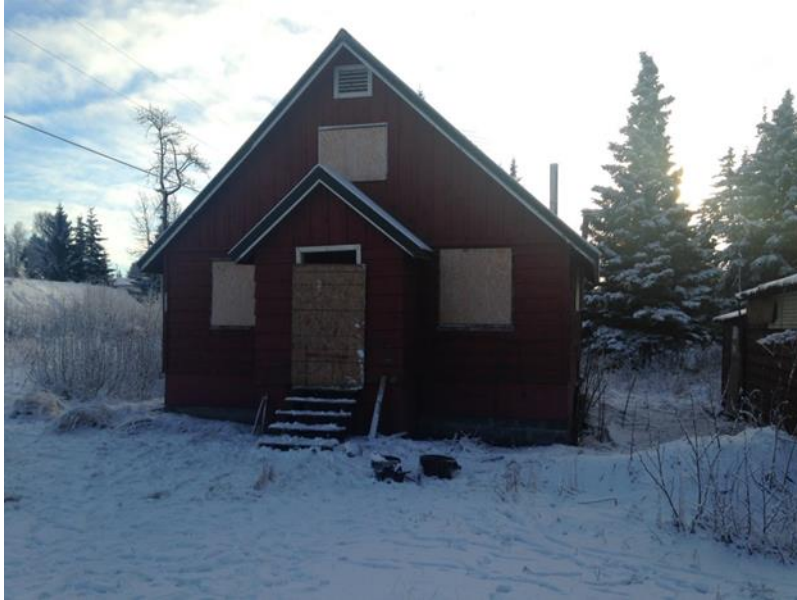
Existing Residential Structure.

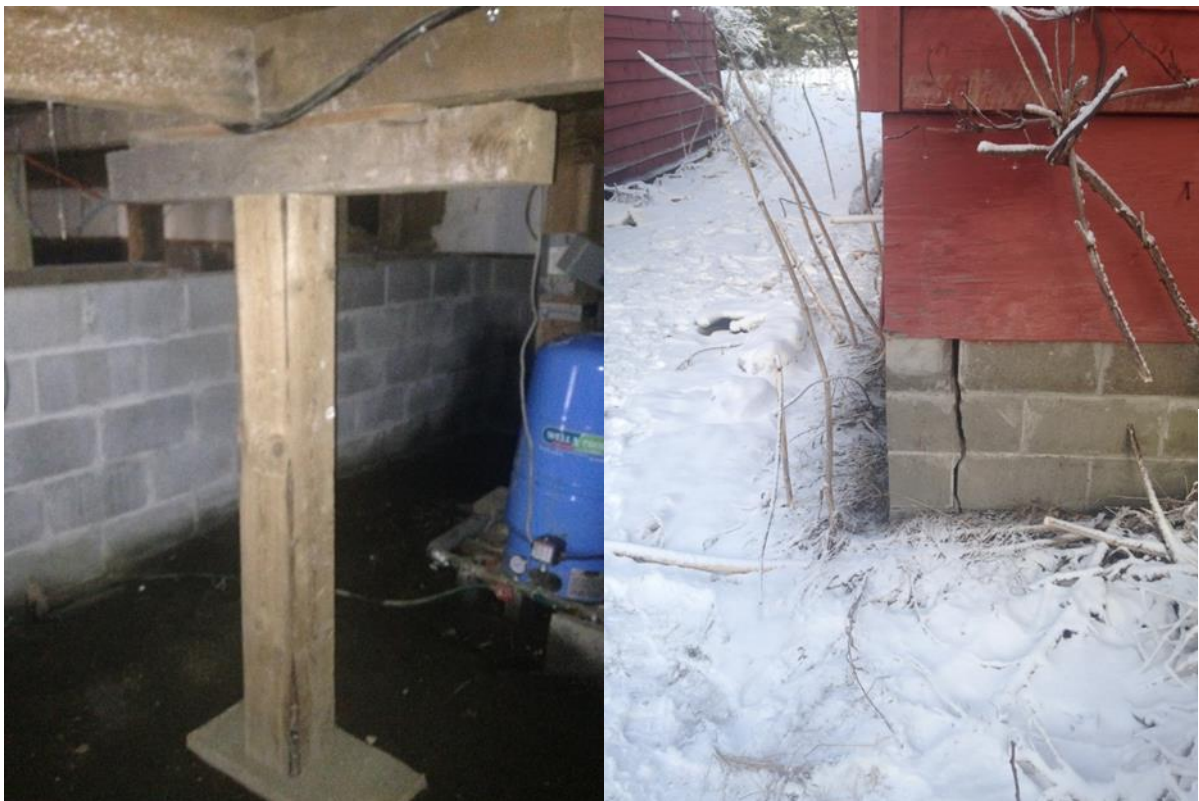
1. The structure was constructed in 1973. The residential structure does not appear to have been constructed to meet any standard building code.
2. The concrete block foundation is cracked from footing to sill plate in numerous locations and splits in excess of 1" wide were observed at corners where one wall is tipping away from the structure.

Foundation Issues

5. It is anticipated that with no heat, the structure, mainly the foundation walls and columns, will deteriorate to an unsafe condition within the next 3-5 years.
