**WINCE – CORTHELL – BRYSON**  
**Consulting Engineers**  
**Box 1041 Kenai, Alaska 99611**  
**Phone 907-283-4672 Fax 907-283-4676**  
**email: mblanning@wcbalaska.com**

December 17, 2021

Subject: Slope Instability Investigation in Cooper Landing

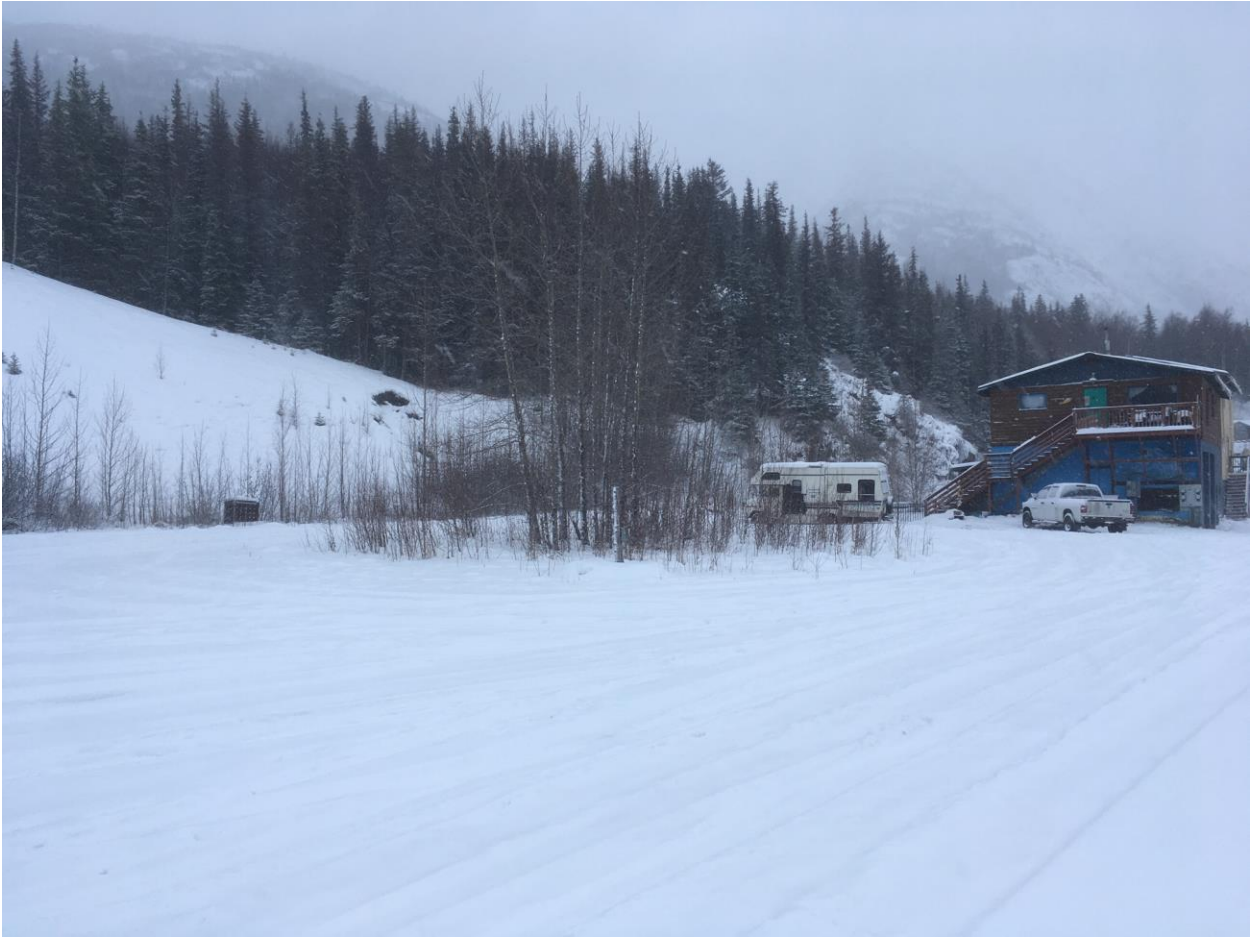
- Although there was a considerable amount of snow cover, the area of the slope failure was visible, see photographs #1, 2, 3 & 4. The eroded area was approximately 50 feet long and 10 feet wide at the widest location. At the upper end of the erosion, the depth was approximately seven feet. The exposed walls of the eroded area showed 2” to 4” of topsoil over gravel. The bottom of the eroded area appears to end approximately fifteen feet from the toe of the slope. Small brush and trees exist along the toe of the slope. No water was observed in or around the eroded area. There is ice build up between the toe of the slope and the structure on the Bunkhouse property (formally Smith property).

Photograph #1: View of failed slope from the Sterling Highway. Affected structure on the right.

- It is likely that during spring break-up, additional erosion of the slope will take place. To help protect the structure on the Bunkhouse property, we recommend placing a temporary barrier between the structure and the toe of the slope to divert silt laden water around the structure. The barrier could be constructed using jersey barriers or drain rock placed in a berm with an impermeable membrane placed on the slope side of the barrier. If drain rock were used to construct the temporary barrier, it could then likely be reused in the permanent repairs to the slope.

- Next summer, once the snow has melted, arrange for an engineer to reinspect the slope and surrounding area. At a minimum, excavate a test hole near the bottom of the slope failure to verify the existing conditions. Also determine the location of the east end of the existing french drain at the toe of the slope, what condition it is in, and also how the drain is connected to the 24" cnp at the west end.

- Next summer make permanent repairs to the slope. The repairs would depend on the conditions found during the engineer's reinspection next summer, however, it is likely that the repairs would include installing vertical french drains, similar to those previously installed on other areas of the slope. Expansion of the french drain to the east, at the toe of the slope, would also likely be included in the repairs.

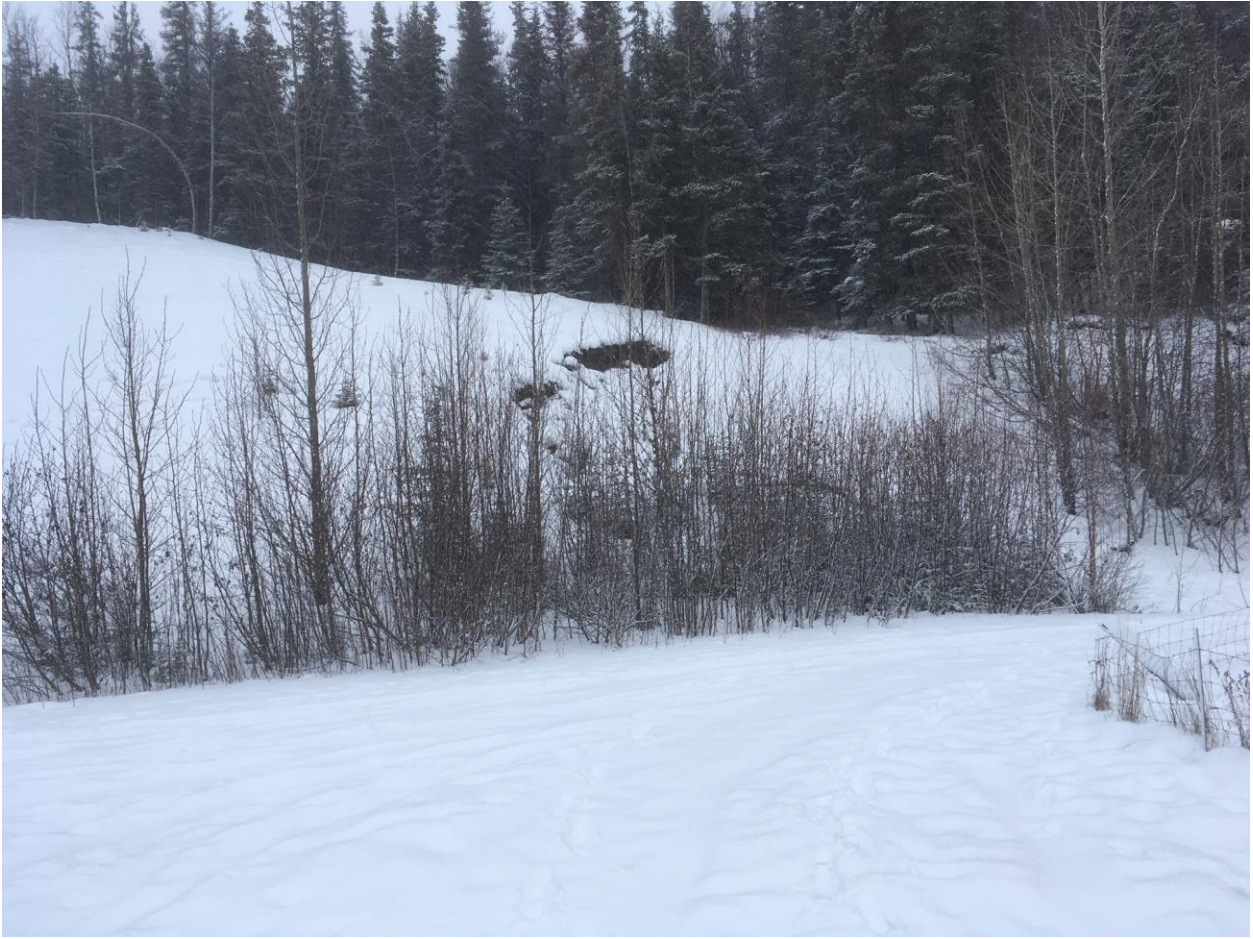
Photograph #2: Area of failed slope.

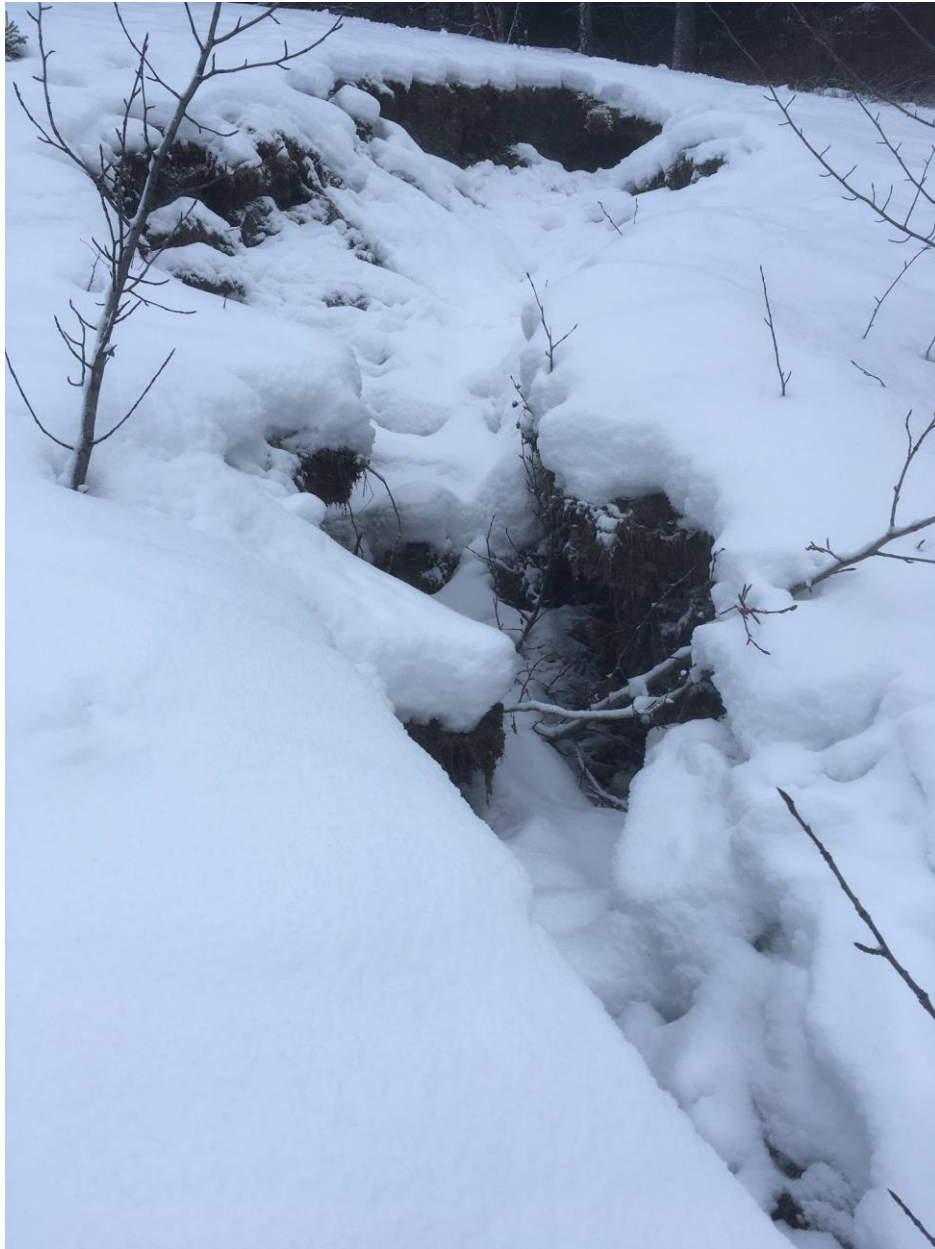
Photograph #3: Failed slope from below.

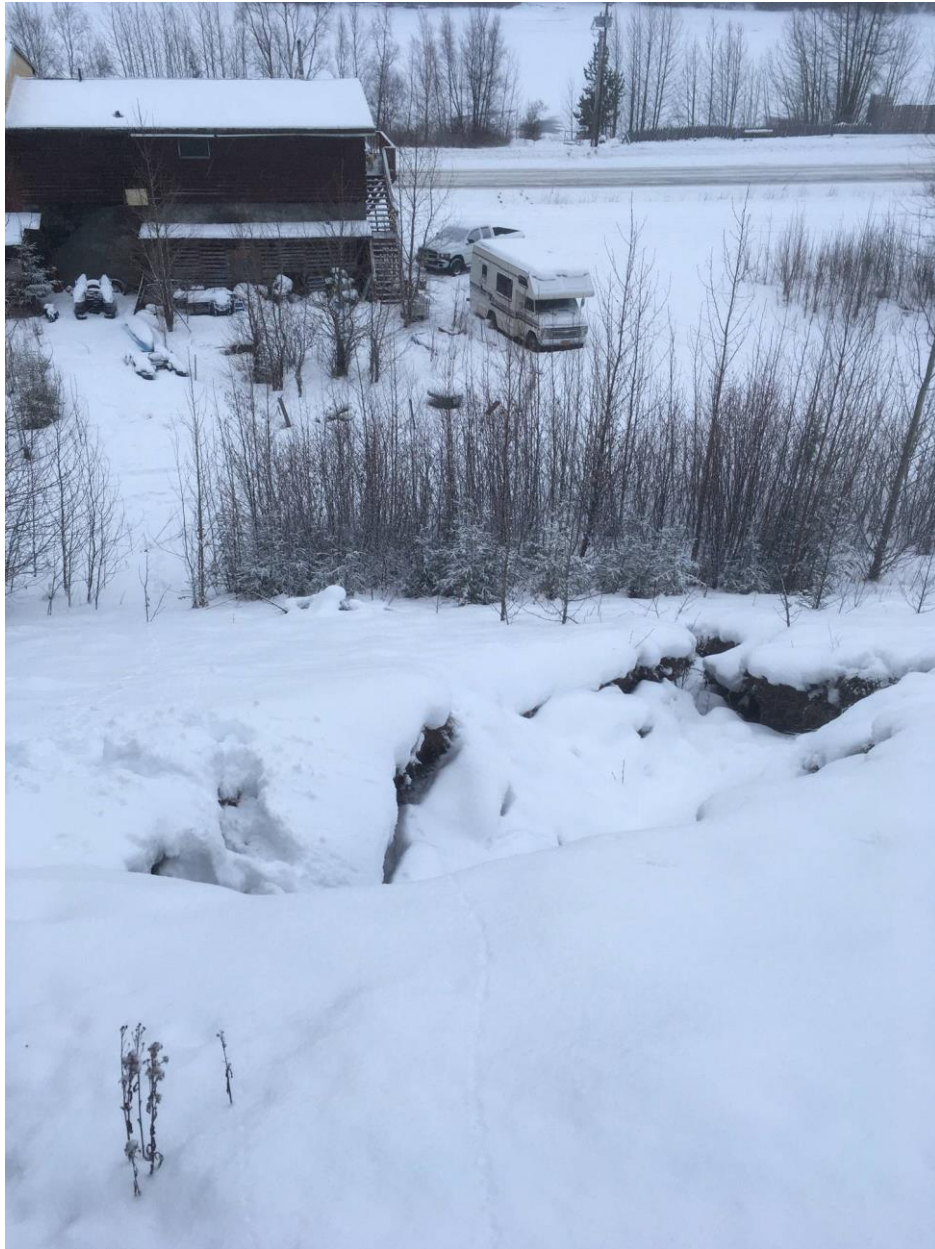
Photograph #4: Failed slope from above.

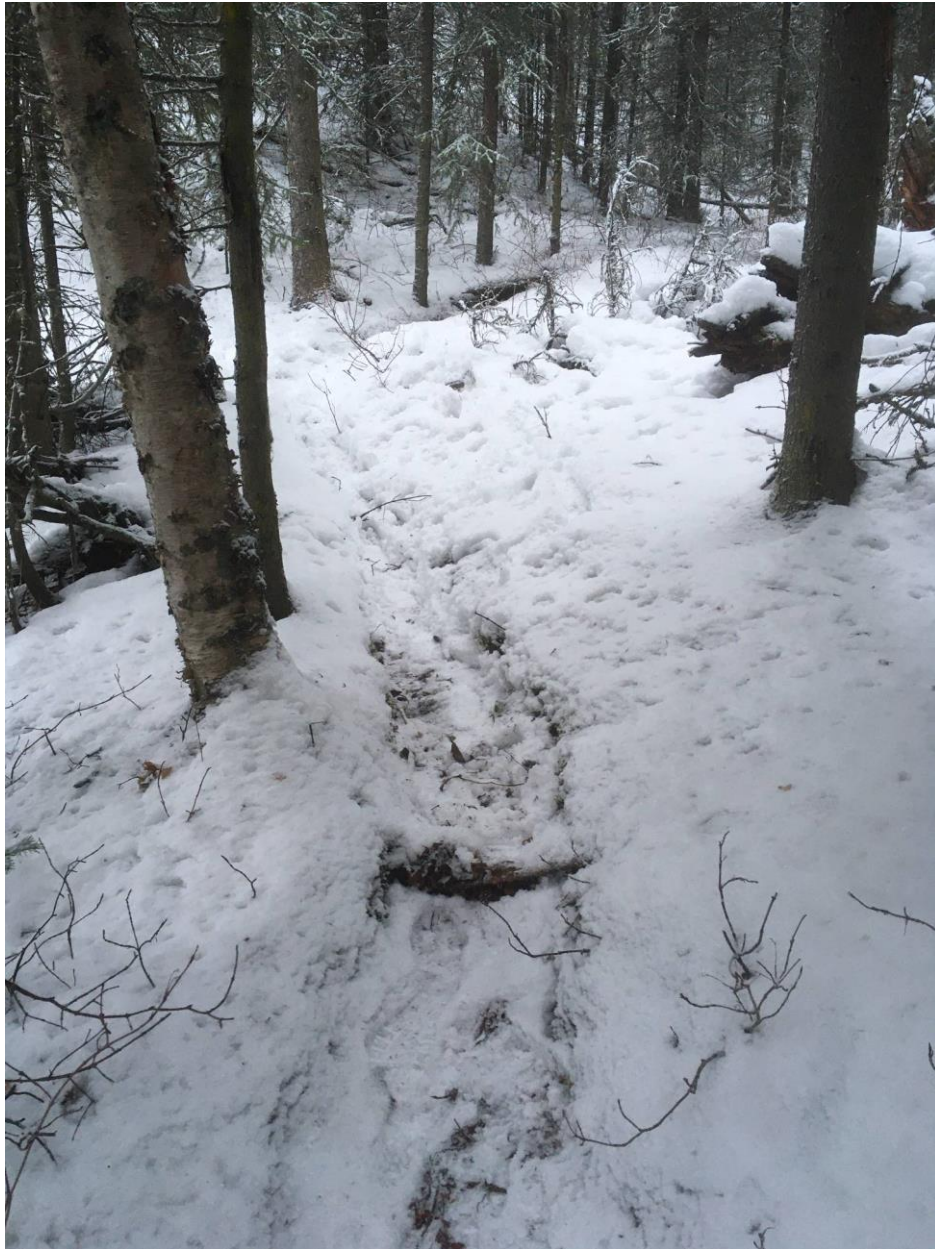
- Up gradient of the slope failure, in the natural vegetation, a drainage way exists, see photograph #5. The drainage way is fairly well defined near the east side of the slope. As you proceed farther up the hillside, the drainage way becomes less defined. Approximately 700 feet up the hillside, several small depressions were observed with open water, see photograph #6.

Photograph #5: Drainage way above failed slope.

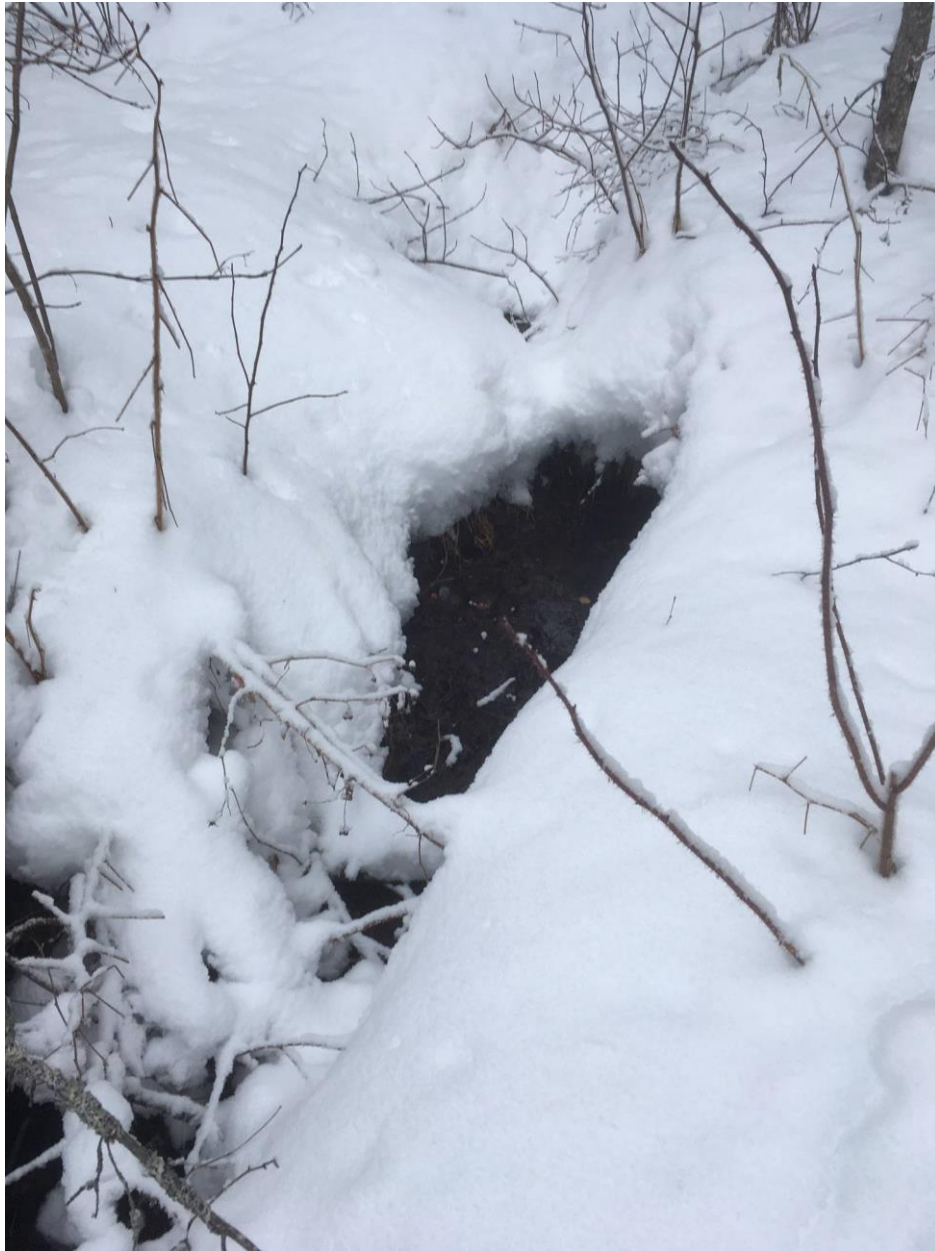
Photograph #6: Depression with open water upgradient from failed slope.

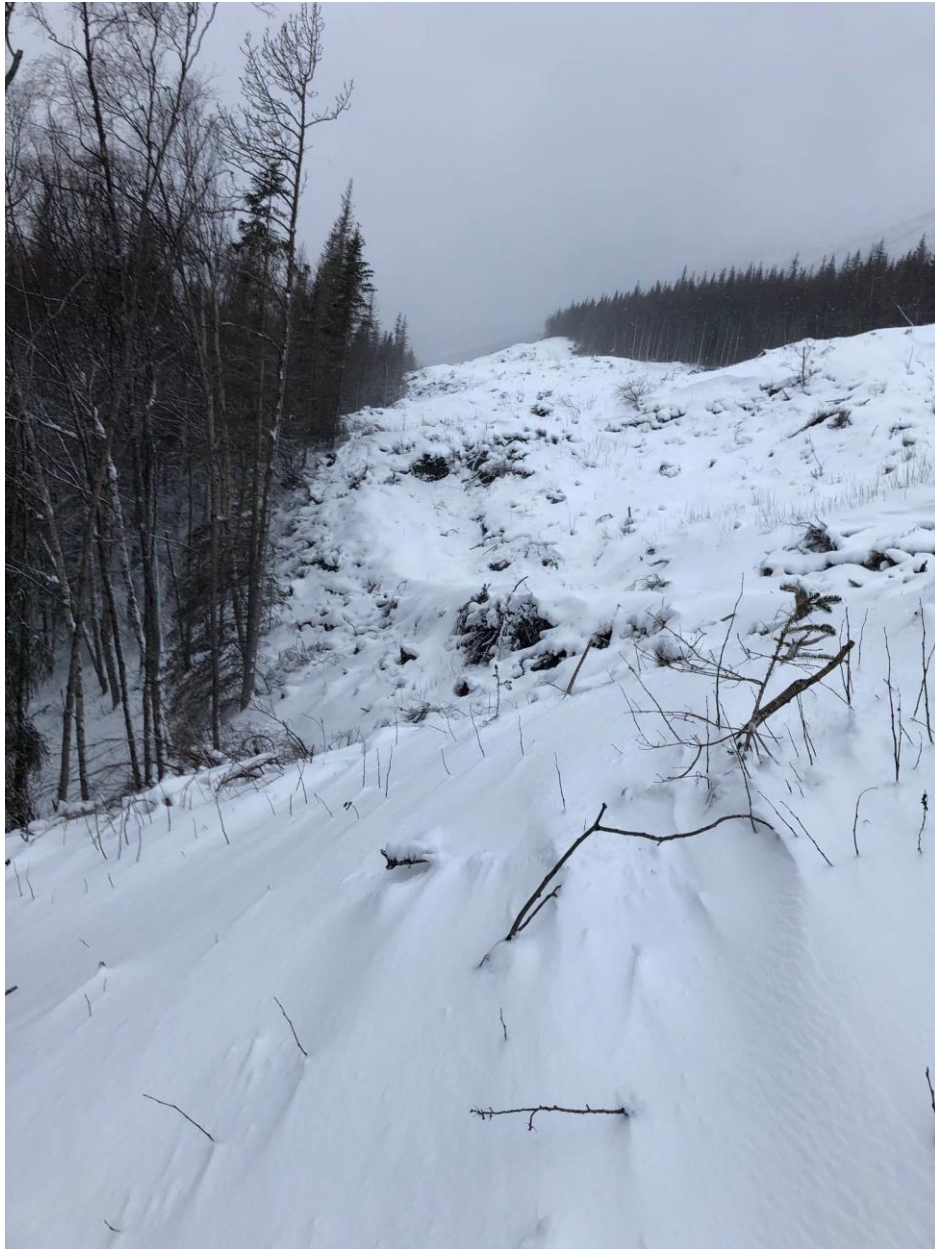
- The centerline of the proposed new route of the Sterling Highway is approximately 1000 feet north of the slope failure. It has been cleared. Although there was 12” to 24” of snow on the ground, it does not appear that any earthwork has been started in this area, see photograph #7.

Photograph #7: Cleared route of proposed new Sterling Highway alignment.

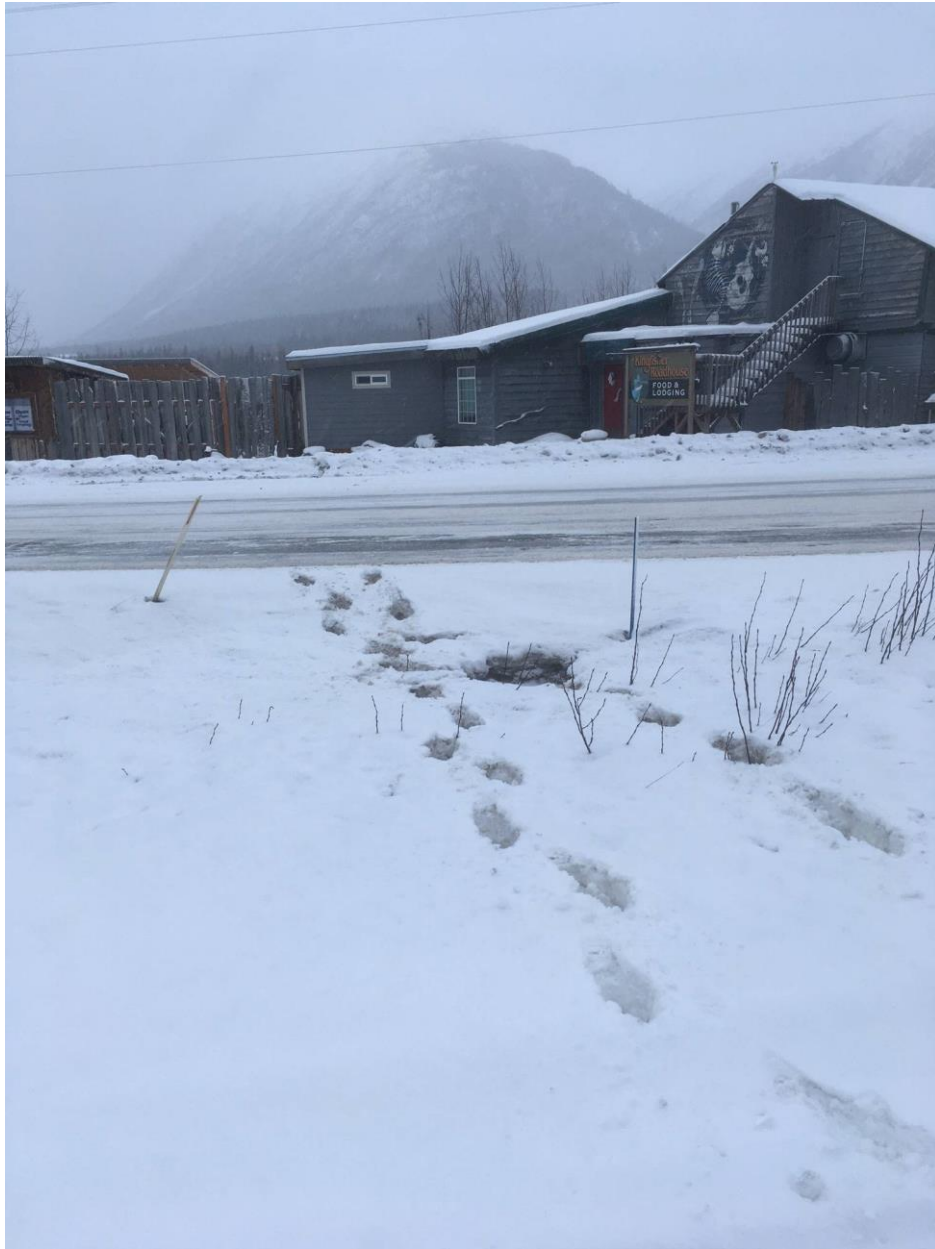
- A catch basin inlet was found within the existing Sterling Highway right-of-way near the west driveway entrance onto the Bunkhouse property, see photograph #8. The inlet had a 24” diameter corrugated metal pipe (cmp) extending towards the northwest corner of the Bunkhouse property and a 24” cmp extending south, under the Highway. The outlet of the 24” cmp, where it discharges to Kenai Lake, was found on the south side of the Kingfisher Roadhouse, see photograph #9. Water was observed flowing through the drainpipe from north to south and discharging to the lake. Two 36” diameter cmp culverts that cross the Highway were also found near the east boundary of the Bunkhouse property. No water was observed flowing through the culverts.

Photograph #8: Catch basin inlet in Sterling Highway right-of-way.

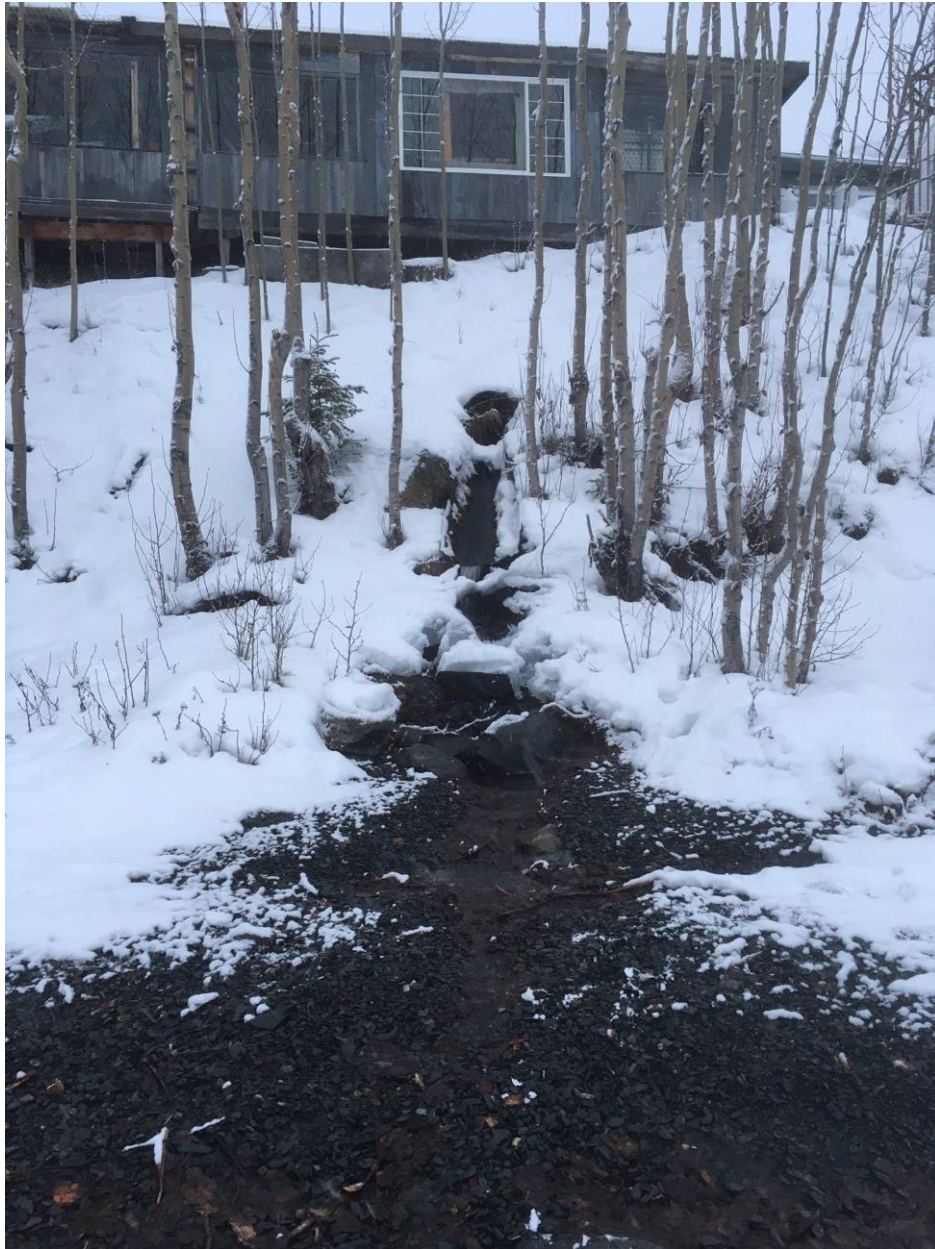
It is our opinion that the rainfall that occurred in late October and early November led to the slope failure. Based on our on-site observations and review of KPB records, it appears that the failure is caused by subsurface water migrating down-slope. This subsurface water saturates the soil, causing the slope to fail. As was noted during our site visit, there is subsurface water

flowing through the drainage pipe and discharging to the lake. This subsurface water appears to be coming from the french drain at the toe of the slope.

Photograph #9: Outlet of drainage pipe south of Kingfisher Roadhouse.
