KENAI PENINSULA BOROUGH

Capital Projects Department

BUILDING INSPECTION REPORT COMMERCIAL BUILDING AT: 2662 NORTH BINKLEY, SOLDOTNA, AK 99669

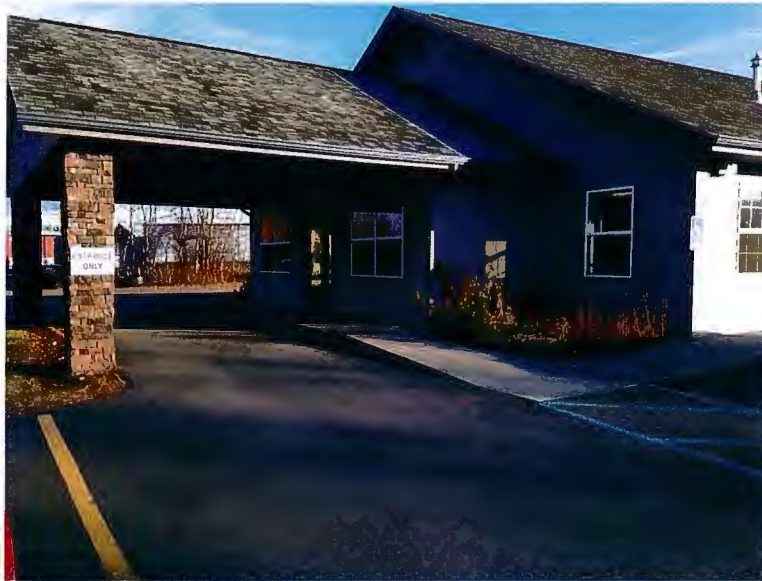
7. Handicap access to the building is addressed sidewalk ramps to the front entry. However, as the slope of the ramps exceeds 2%, there should be handrails installed to meet current ADA compliance.

8. There is one handicap space identified which is adequate. The handicap sign is currently mounted about 48" above the sidewalk. ADA requires the sign to be mounted at 60", and since the one space should be van accessible, a sign should be added identifying the space as van accessible.

Photo 1: Entry showing handicap ramps and HC parking sign

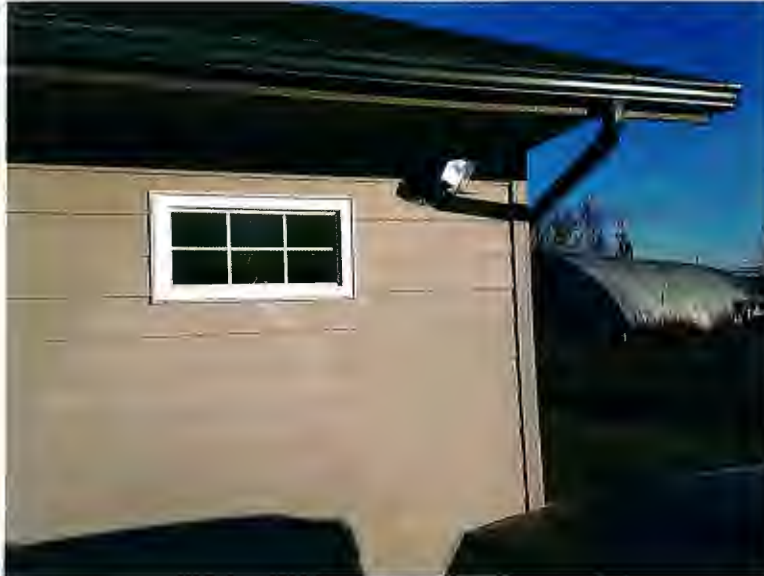
6. One building mounted parking lot light is missing a mounting screw which allows the light to rotate. A new screw should be installed to firmly attach the fixture.

Photo 2: Light fixture needs second mounting screw.

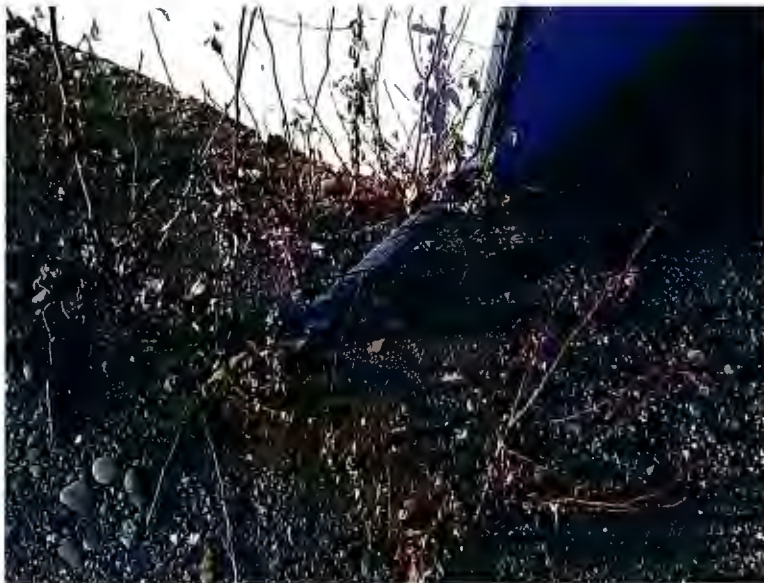
4. There appears to be adequate slope away from the structure to properly drain run-off away without impacting the foundation.
5. There are adequate rain gutters for the building with downspouts located where there is little to no impact on sidewalks. One downspout extension has had one end crushed and needs to be opened up to allow free flow of drainage.

Phot 3: Crushed downspout extension.

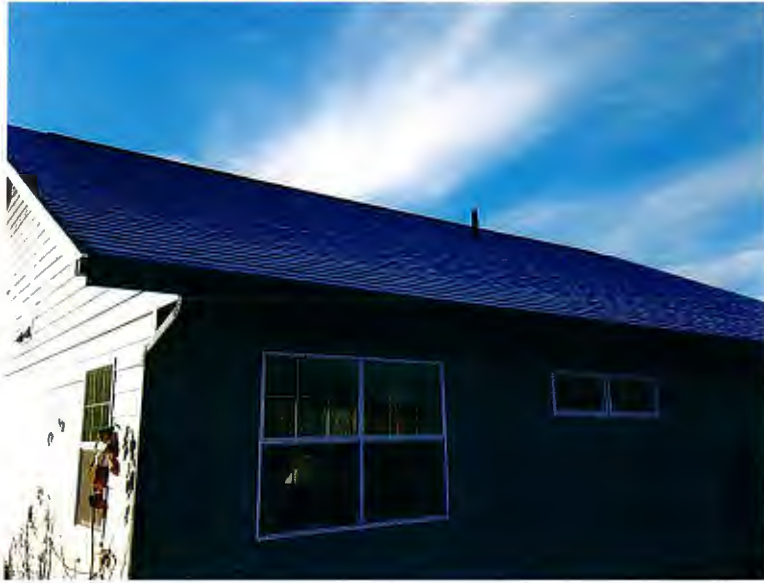
13. Due to the recent age of construction, it would be assumed that lead paint and asbestos containing materials were not utilized during construction.
14. The roofing is architectural grade asphalt shingles that appear to be in excellent condition. As the morning was somewhat cool, frost was observed on the shade side of the roof. The presence of the frost in an even coverage is an indication that there is adequate ventilation of the attic space and good insulation above the ceiling.
15. The building is heated with a forced air system with the main heat / cooling source a ground mounted packaged HVAC unit located on the north side of the building. The fuel source is natural gas.
16. There appeared to be no ADA compliance issues inside the facility.

Photo 4: Frost on roof showing ventilation and insulation quality.

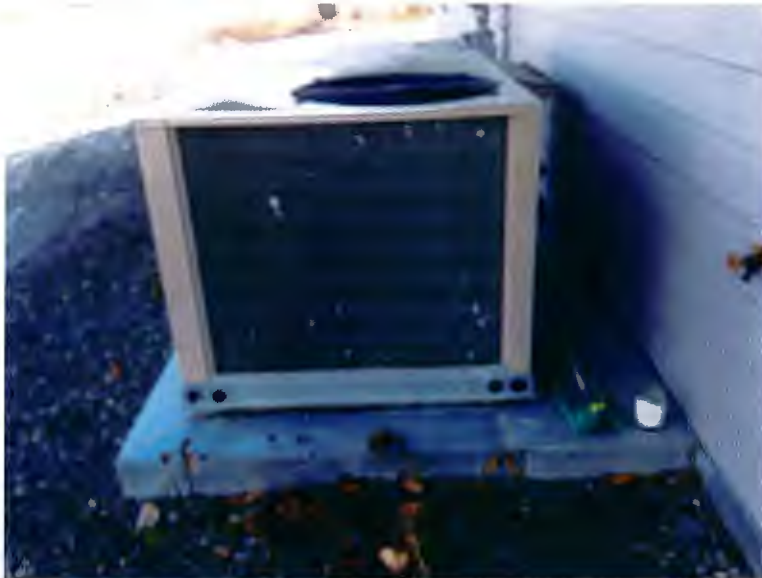
Photo 5: Gas fired, ground mounted, package HVAC unit.
