WINCE – CORTHELL – BRYSON
Consulting Engineers
Box 1041 Kenai, Alaska 99611
Phone 907-283-4672 Fax 907-283-4676
email: mblanning@wcbalaska.com

December 17, 2021

Subject: Slope Instability Investigation in Cooper Landing

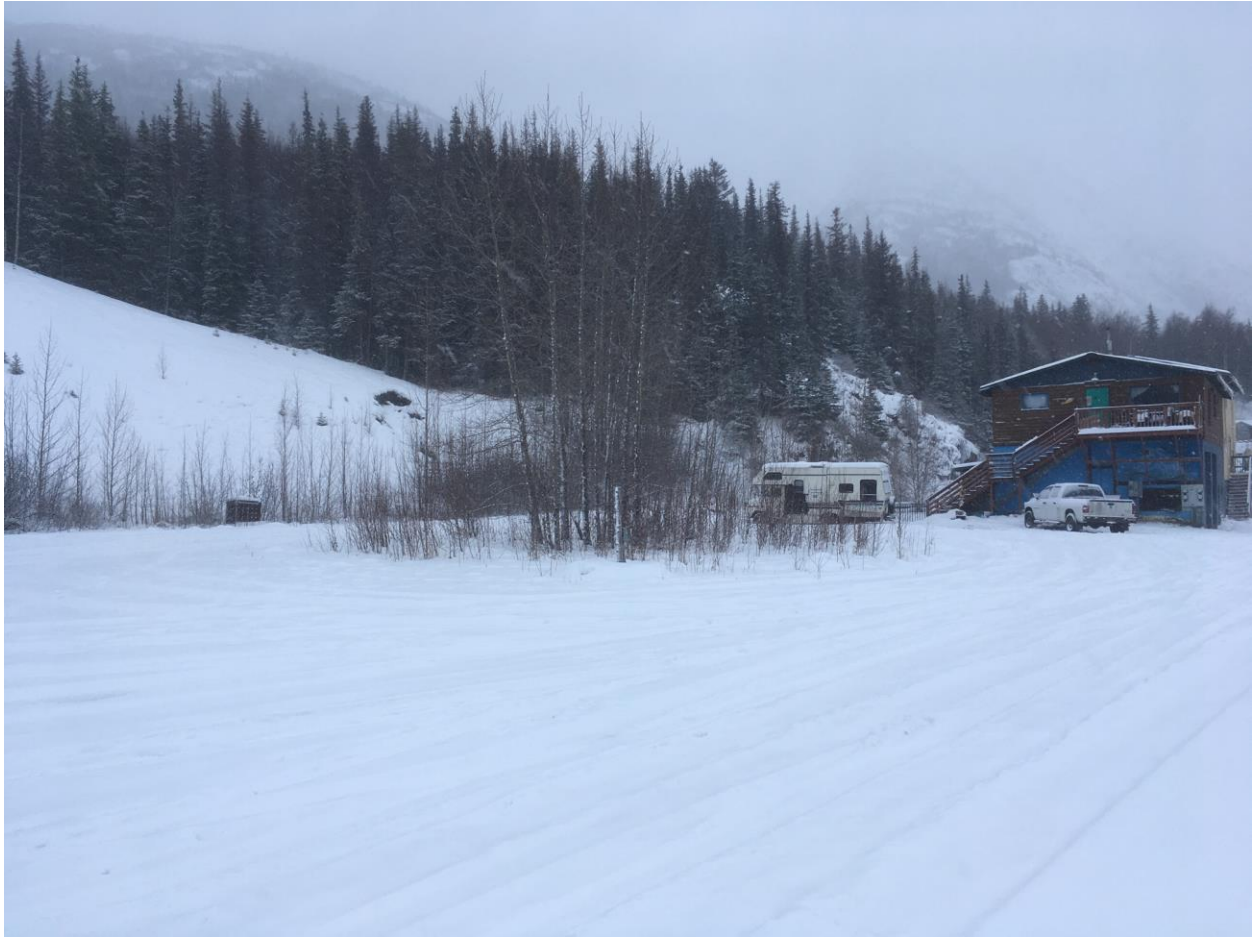
- Although there was a considerable amount of snow cover, the area of the slope failure was visible, see photographs #1, 2, 3 & 4. The eroded area was approximately 50 feet long and 10 feet wide at the widest location. At the upper end of the erosion, the depth was approximately seven feet. The exposed walls of the eroded area showed 2" to 4" of topsoil over gravel. The bottom of the eroded area appears to end approximately fifteen feet from the toe of the slope. Small brush and trees exist along the toe of the slope. No water was observed in or around the eroded area. There is ice build up between the toe of the slope and the structure on the Bunkhouse property (formally Smith property).

It is our opinion that the rainfall that occurred in late October and early November led to the slope failure. Based on our on-site observations and review of KPB records, it appears that the failure is caused by subsurface water migrating down-slope. This subsurface water saturates the soil, causing the slope to fail. As was noted during our site visit, there is subsurface water

Photograph #1: View of failed slope from the Sterling Highway. Affected structure on the right.

- It is likely that during spring break-up, additional erosion of the slope will take place. To help protect the structure on the Bunkhouse property, we recommend placing a temporary barrier between the structure and the toe of the slope to divert silt laden water around the structure. The barrier could be constructed using jersey barriers or drain rock placed in a berm with an impermeable membrane placed on the slope side of the barrier. If drain rock were used to construct the temporary barrier, it could then likely be reused in the permanent repairs to the slope.

- Next summer make permanent repairs to the slope. The repairs would depend on the conditions found during the engineer's reinspection next summer, however, it is likely that the repairs would include installing vertical french drains, similar to those previously installed on other areas of the slope. Expansion of the french drain to the east, at the toe of the slope, would also likely be included in the repairs.

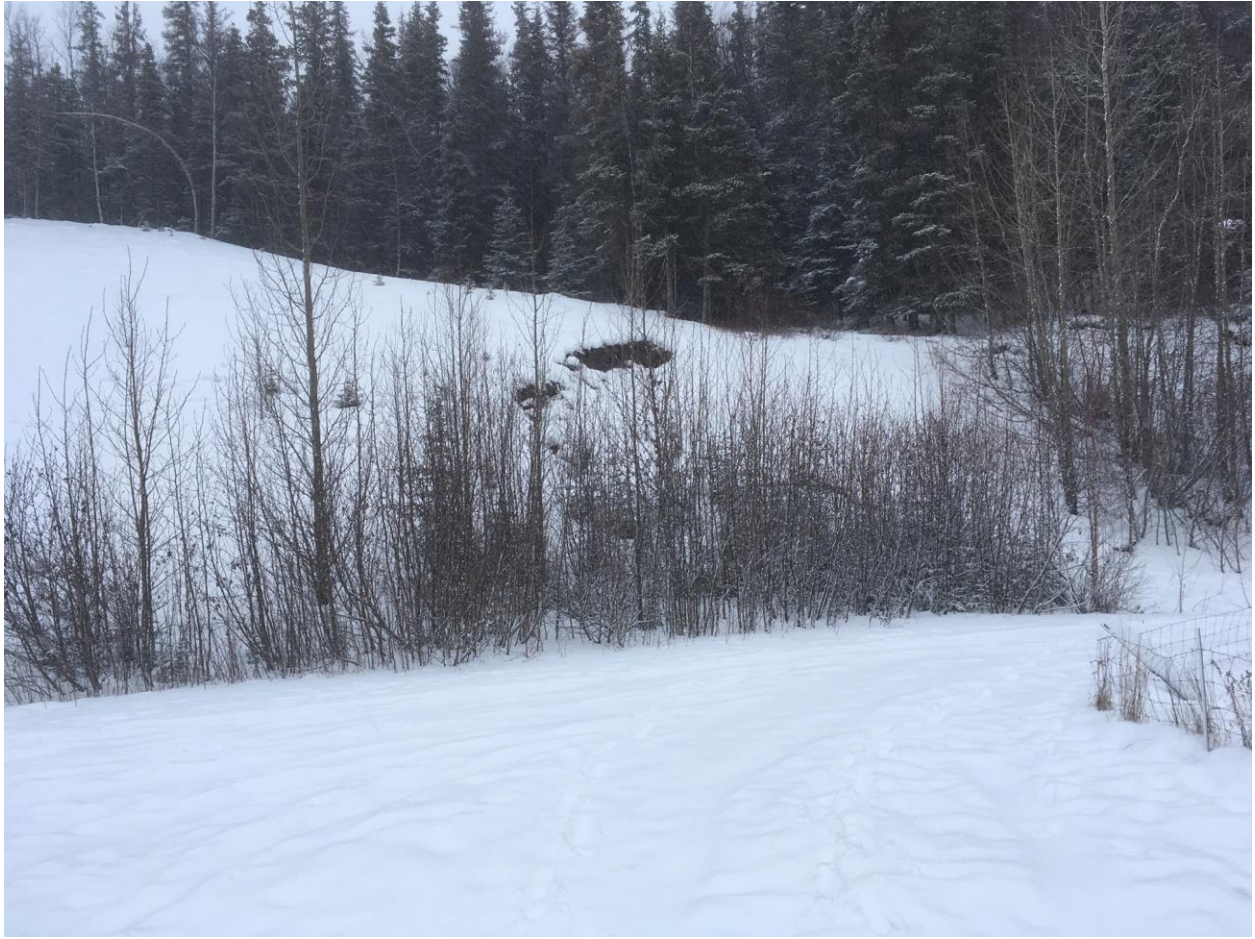
Photograph #2: Area of failed slope.

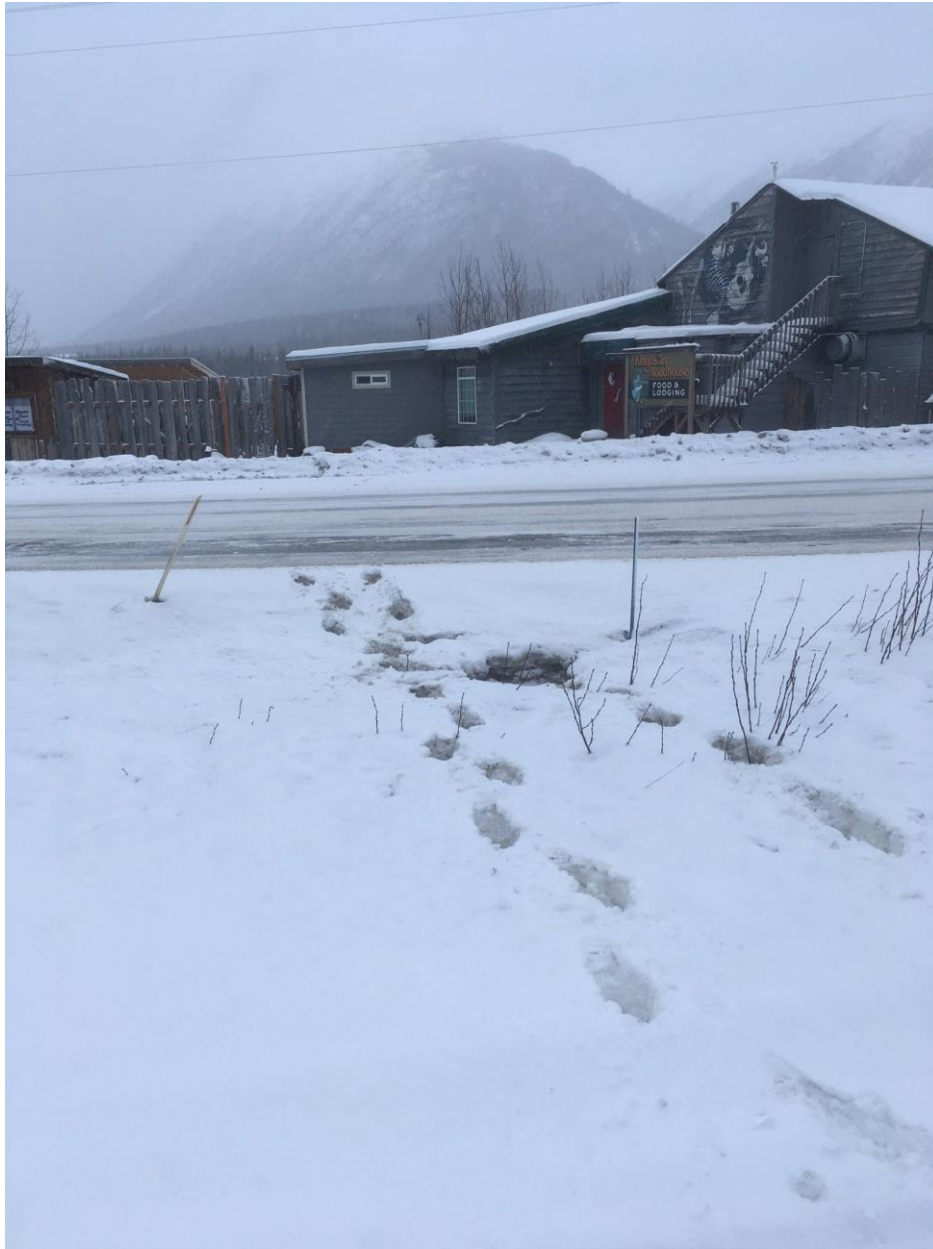
- A catch basin inlet was found within the existing Sterling Highway right-of-way near the west driveway entrance onto the Bunkhouse property, see photograph #8. The inlet had a 24" diameter corrugated metal pipe (cmp) extending towards the northwest corner of the Bunkhouse property and a 24" cmp extending south, under the Highway. The outlet of the 24" cmp, where it discharges to Kenai Lake, was found on the south side of the Kingfisher Roadhouse, see photograph #9. Water was observed flowing through the drainpipe from north to south and discharging to the lake. Two 36" diameter cmp culverts that cross the Highway were also found near the east boundary of the Bunkhouse property. No water was observed flowing through the culverts.

Photograph #8: Catch basin inlet in Sterling Highway right-of-way.

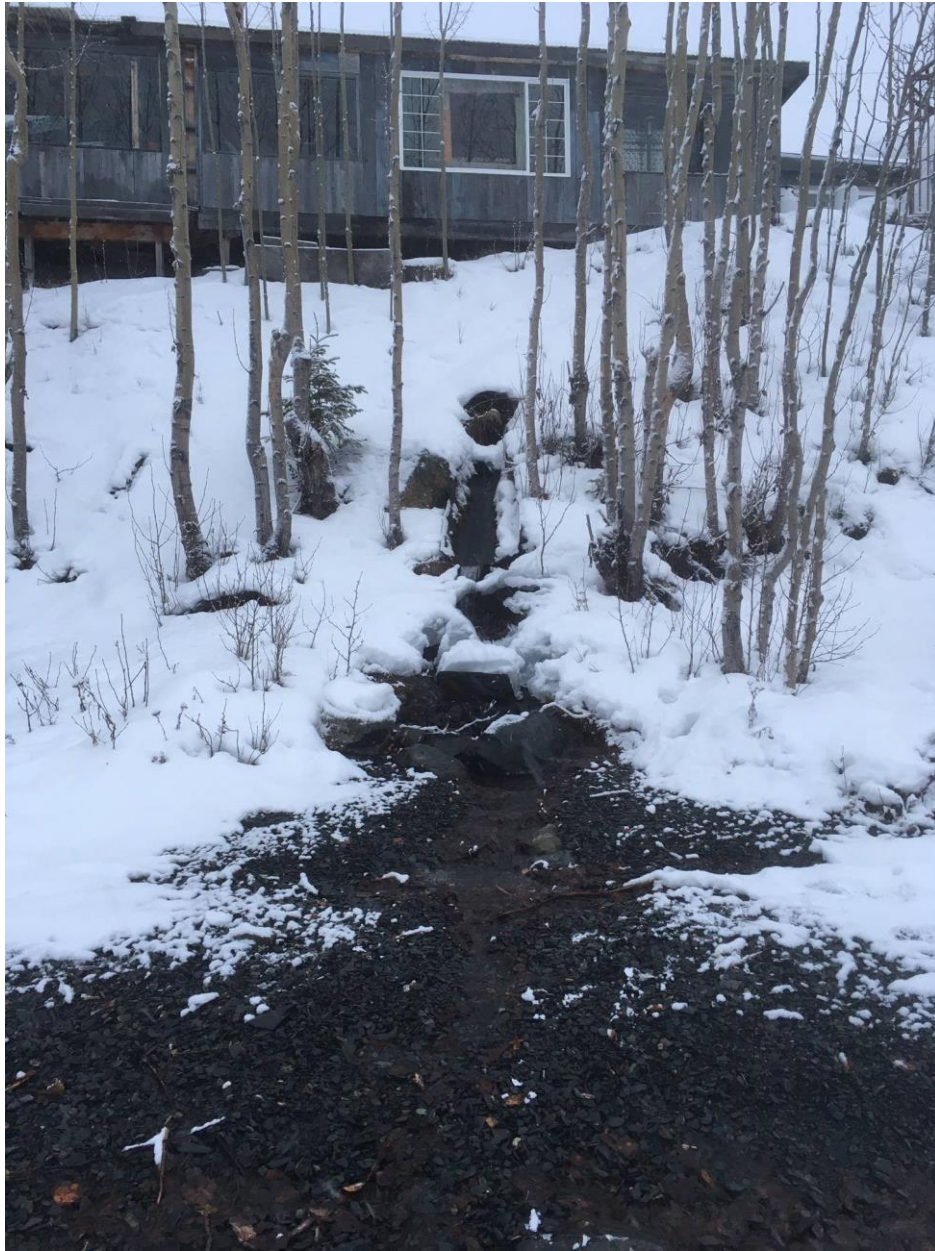
flowing through the drainage pipe and discharging to the lake. This subsurface water appears to be coming from the french drain at the toe of the slope.

Photograph #9: Outlet of drainage pipe south of Kingfisher Roadhouse.
