KENAI PENINSULA BOROUGH

Capital Projects Department

BUILDING INSPECTION REPORT RESIDENCE LOCATED AT: 72421 MILO FRITZ AVE., ANCHOR POINT, AK 99556

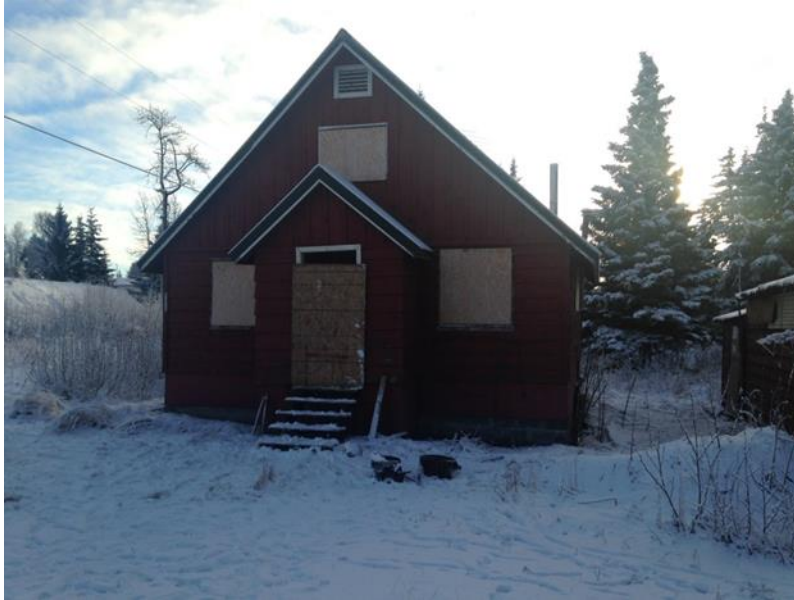
Existing Residential Structure.

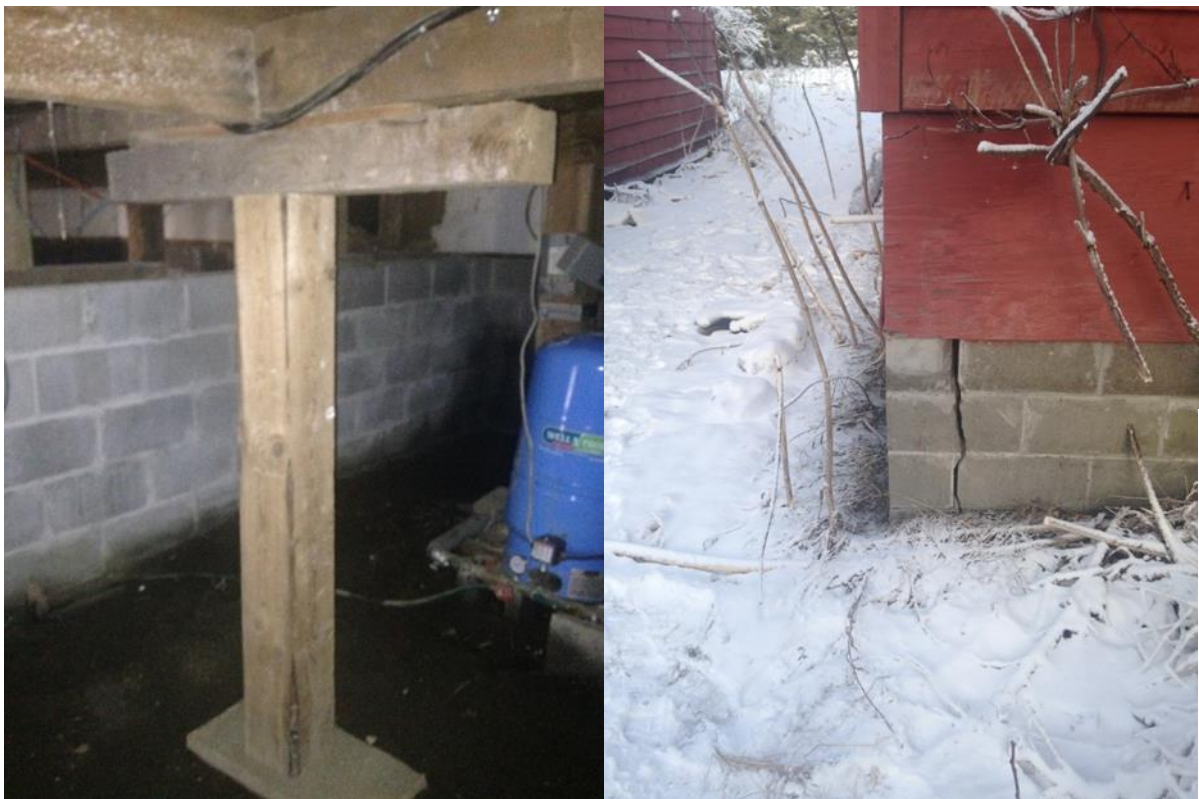
1. The structure was constructed in 1973. The residential structure does not appear to have been constructed to meet any standard building code.
2. The concrete block foundation is cracked from footing to sill plate in numerous locations and splits in excess of 1" wide were observed at corners where one wall is tipping away from the structure.

3. Interior foundation supports are provided with wood posts sitting on non-treated wood blocks. The crawl space is currently muddy, with the appearance that it had not been too long since there was standing water present.

Foundation Issues

5. It is anticipated that with no heat, the structure, mainly the foundation walls and columns, will deteriorate to an unsafe condition within the next 3-5 years.
