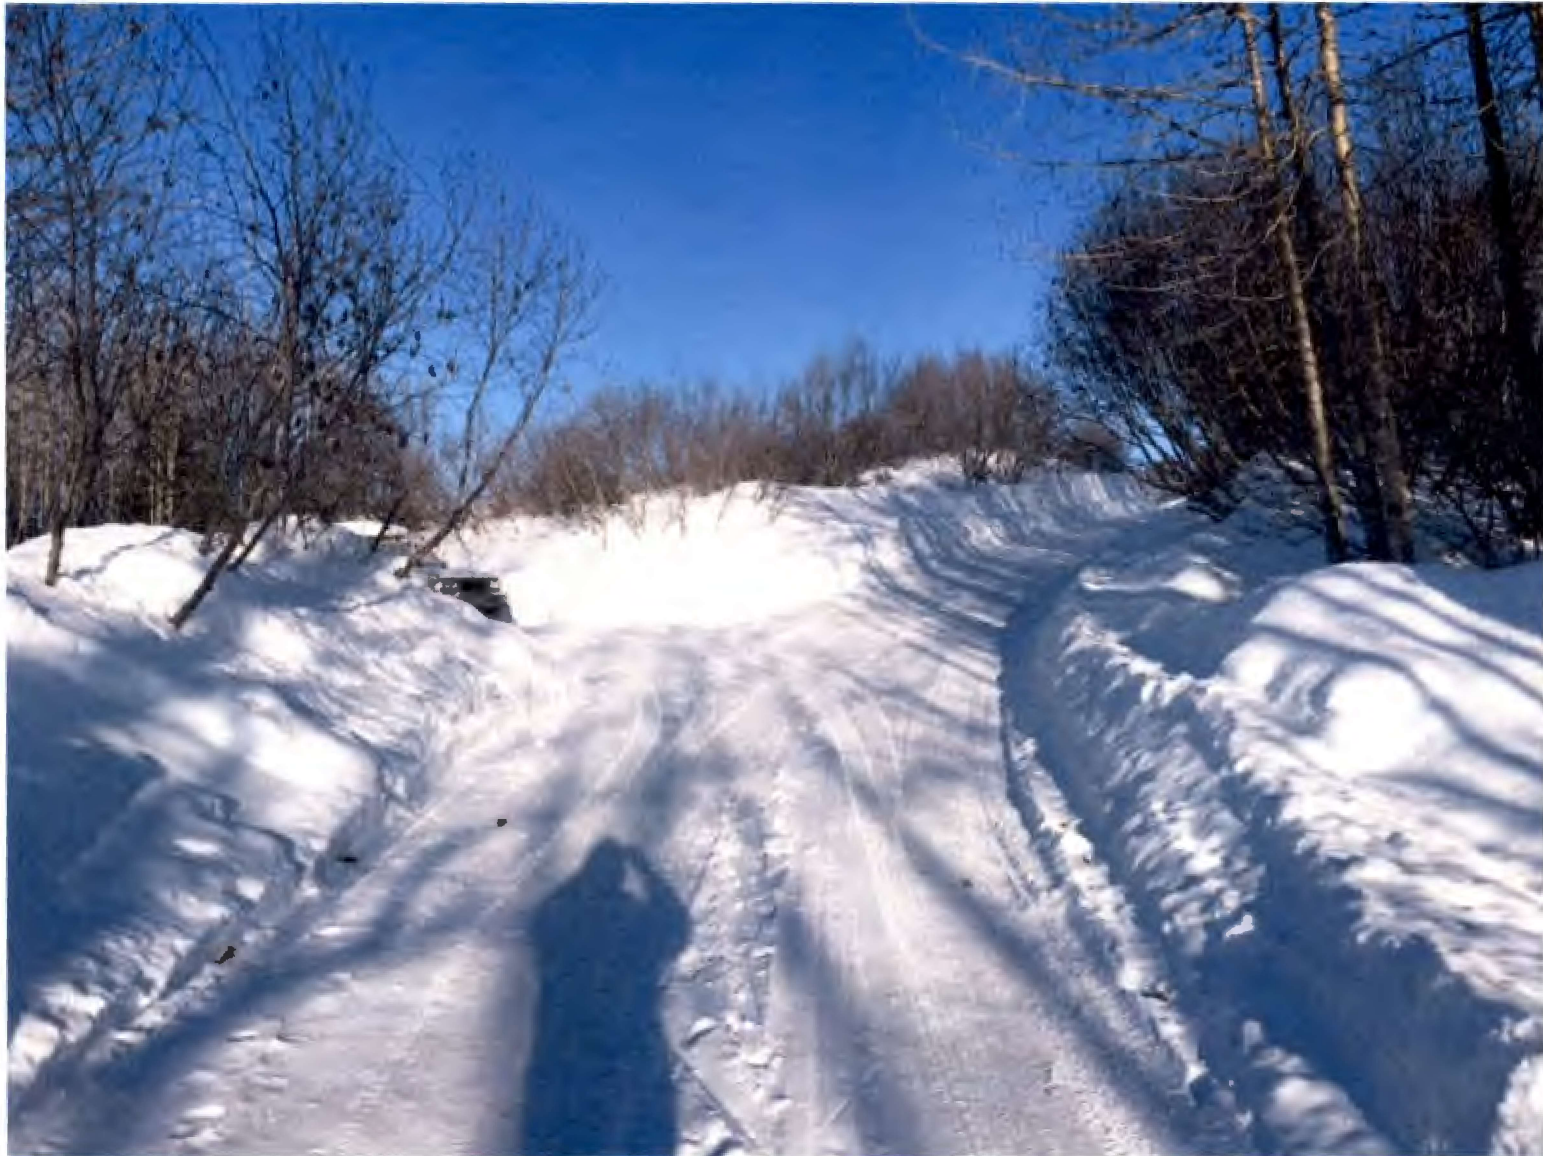
Viewing NW, “up” Greenwood Road

- notice tight alders bordering unmaintained road; this project has actually improved snow removal
- project is actually on “outside” of curve; no influence on vehicle visibility

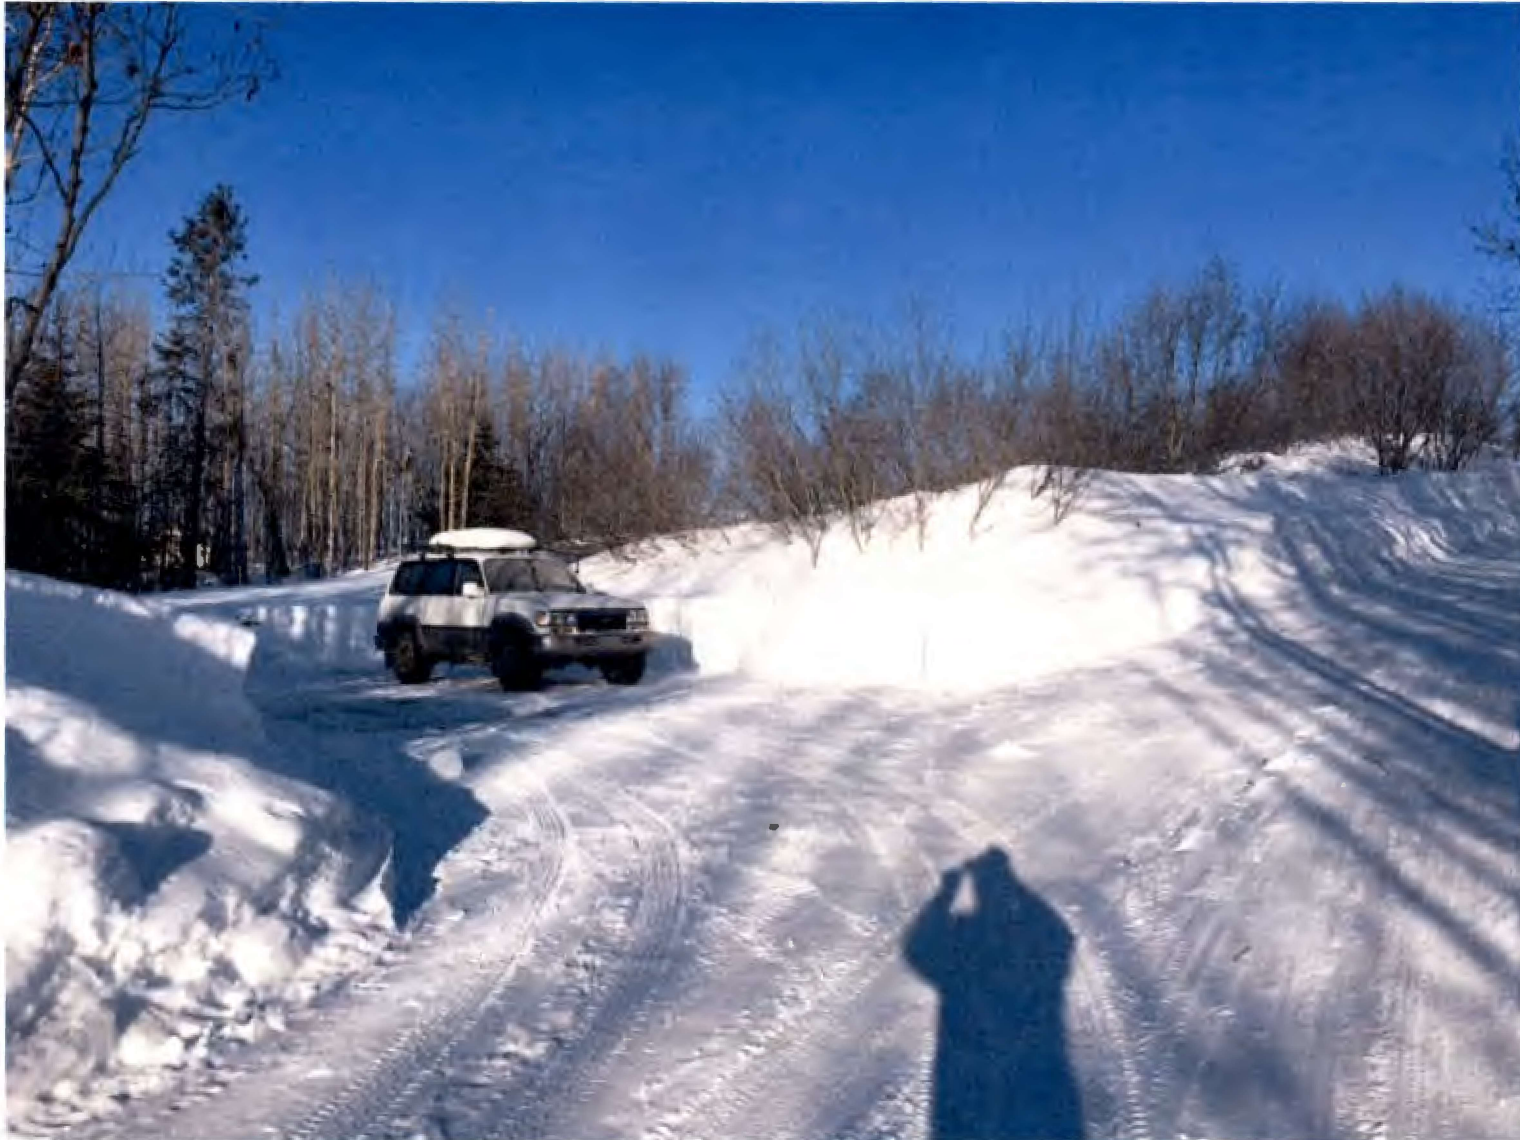
Viewing W, “up” Greenwood Road, into the project

-notice rebar next to snowdrift; this would be front of project

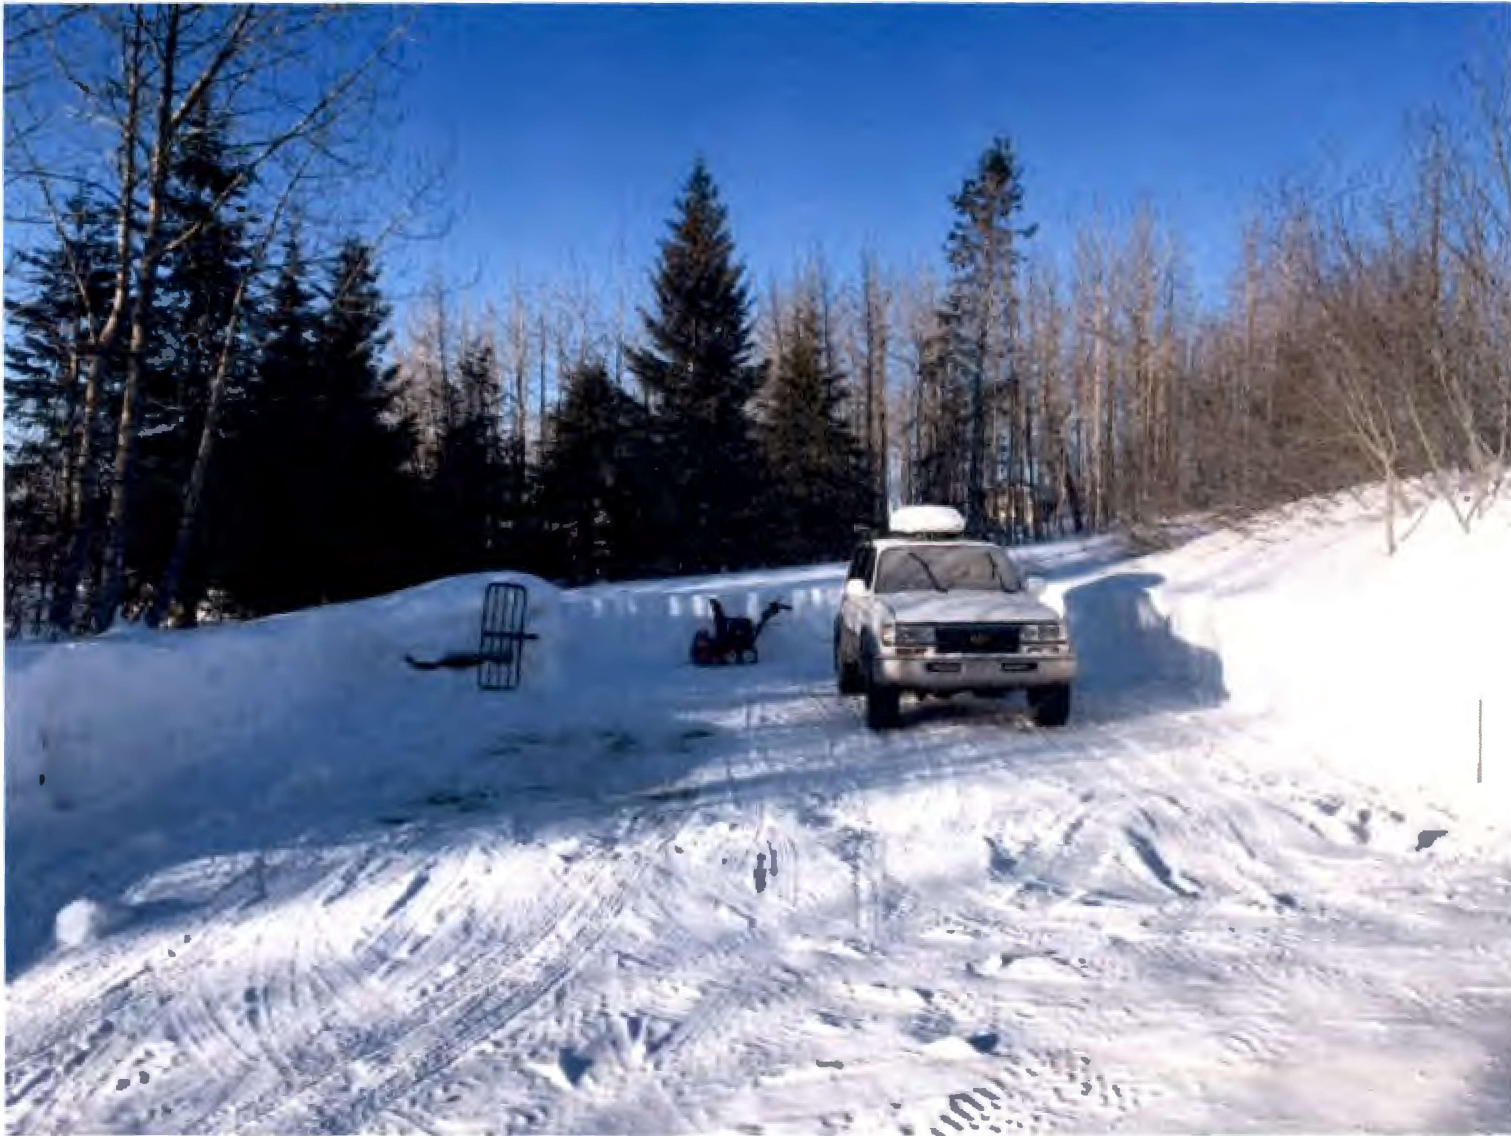
Viewing S, into the project

-notice two rebar (left and right) as front project borders

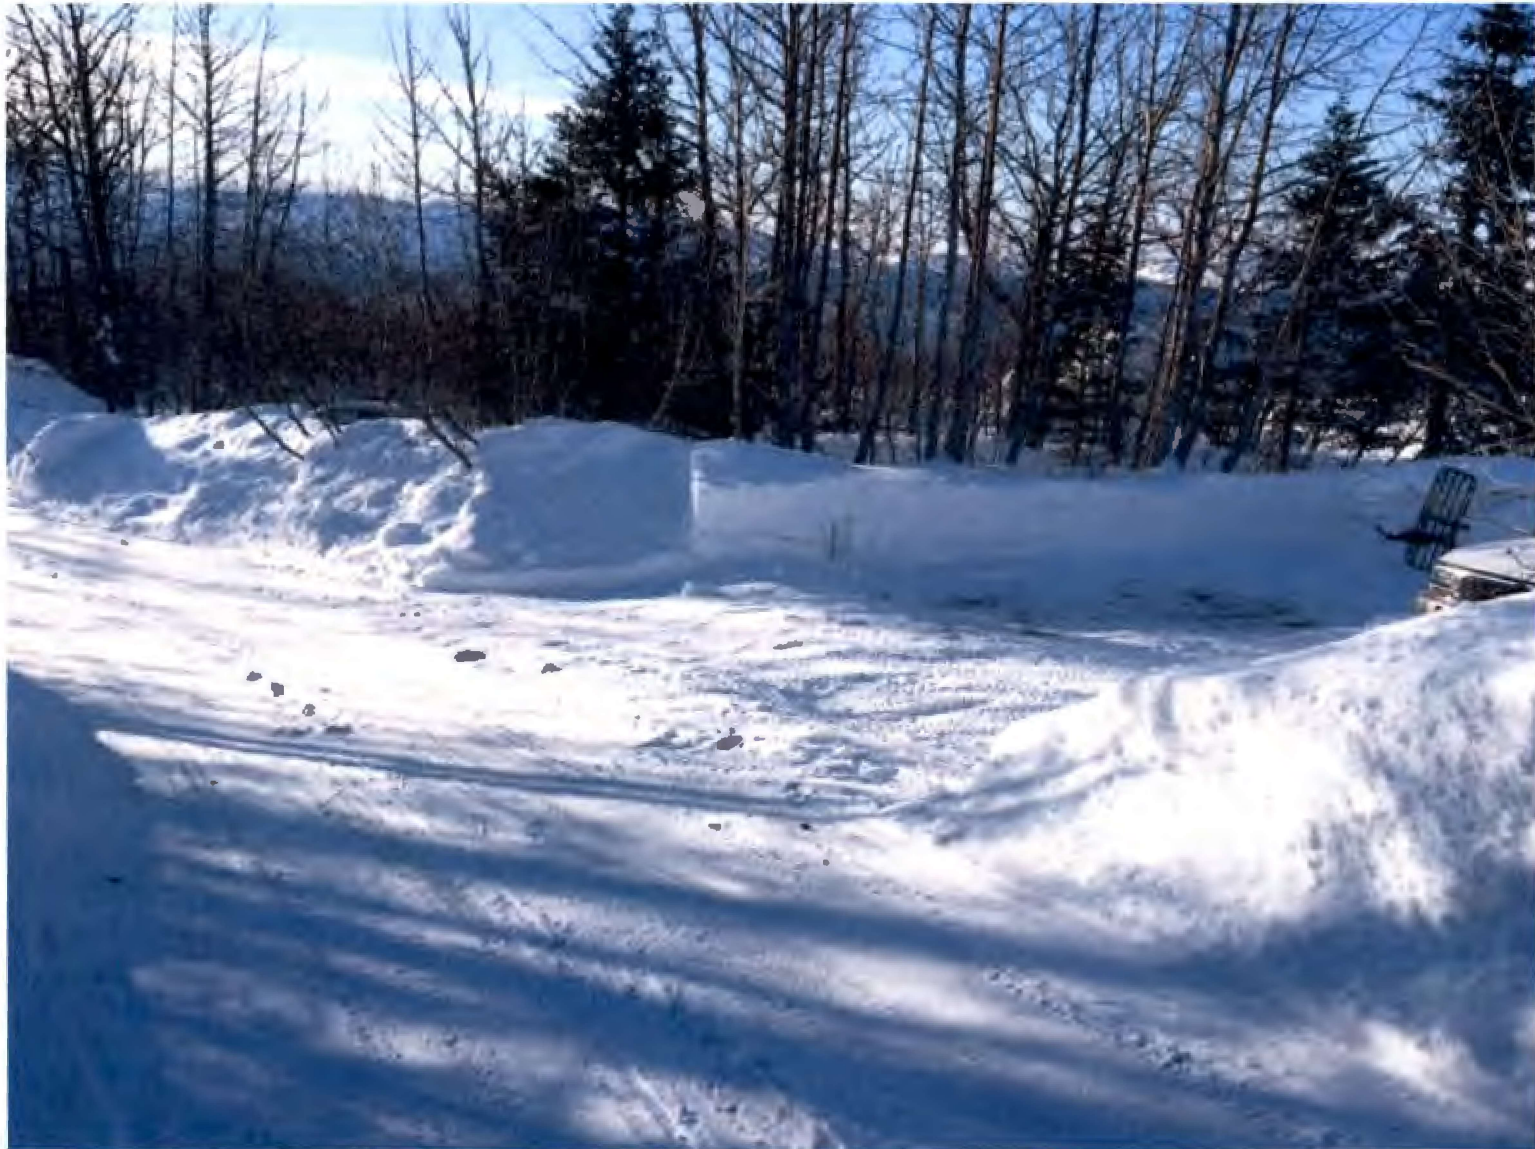
Viewing SSE, “down” Greenwood Road, into project area
-notice rebar showing front border of project

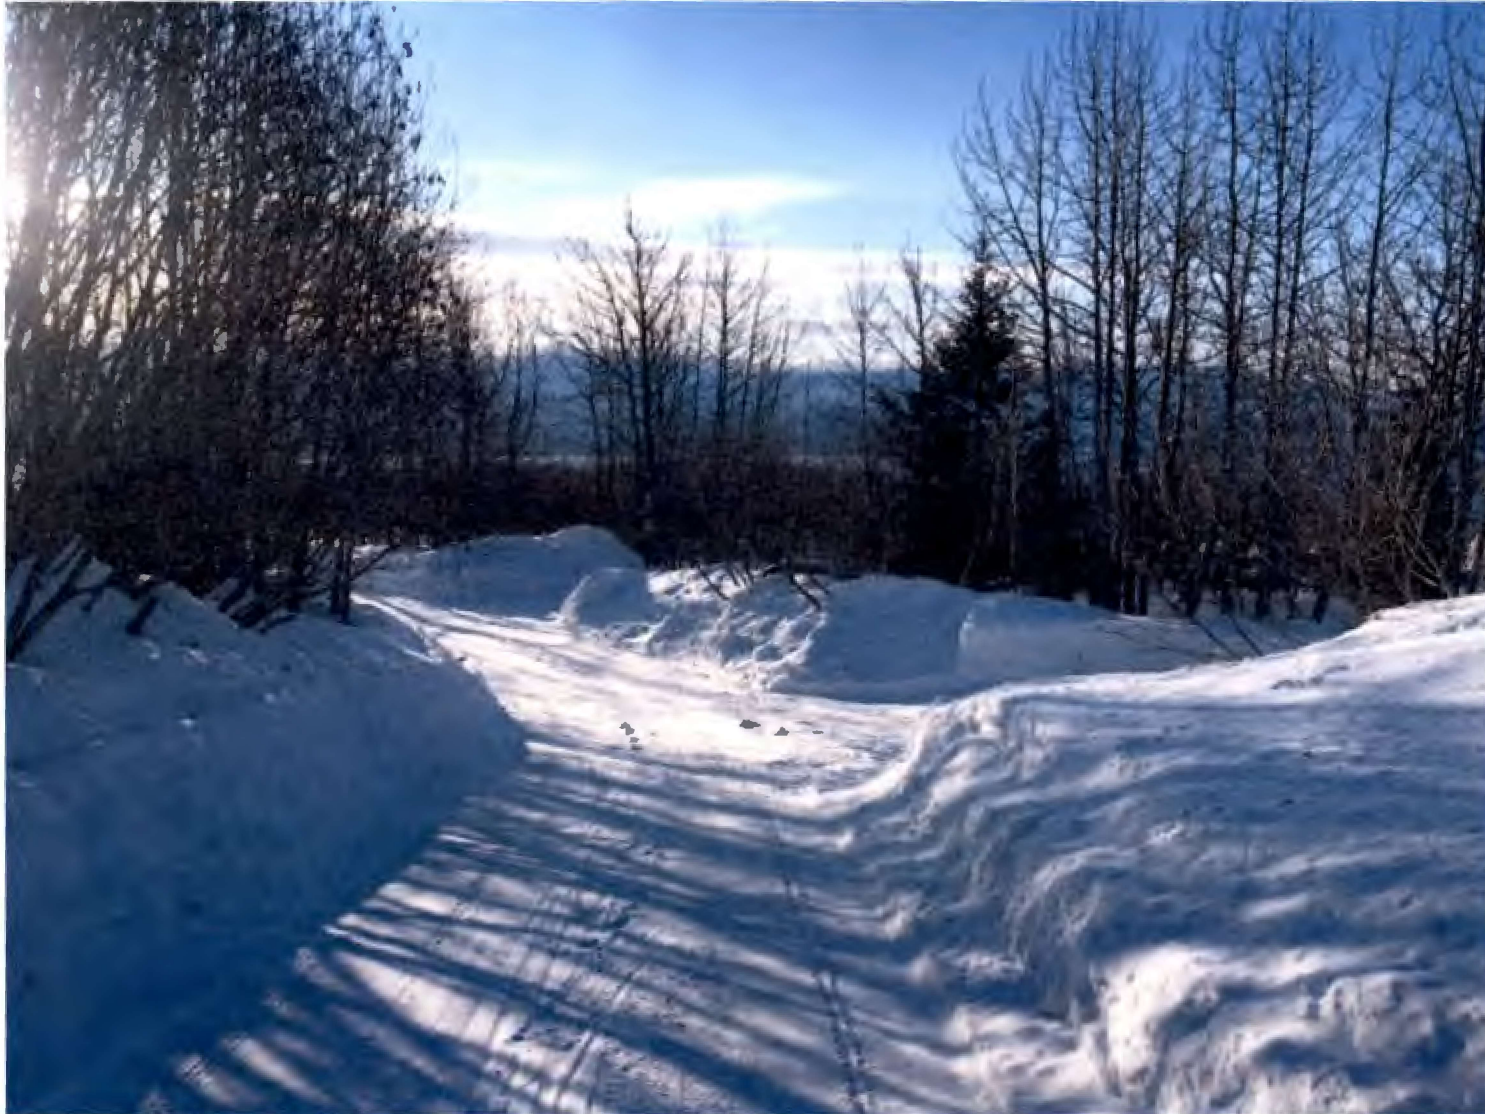
Viewing SE, “down” Greenwood Road

-traffic would typically be 2 or 3 vehicles per day
