- 1. Trout View Subdivision; KPB File 2022-127**

KPB File 2022-127
T 05N R 08W SEC 29
Funny River

Specific Request / Scope of Subdivision: This is an exception request for a preliminary plat that was previously granted conditional approval by the Kenai Peninsula Borough Plat Committee at the meeting of September 26, 2022. Approval or denial of this request will not void or change the outcome nor the date of the conditional approval.

Figure 2.
Wetlands and Waters of the
Lakefront Drive Wetlands
Study Area, Alaska, 2021.

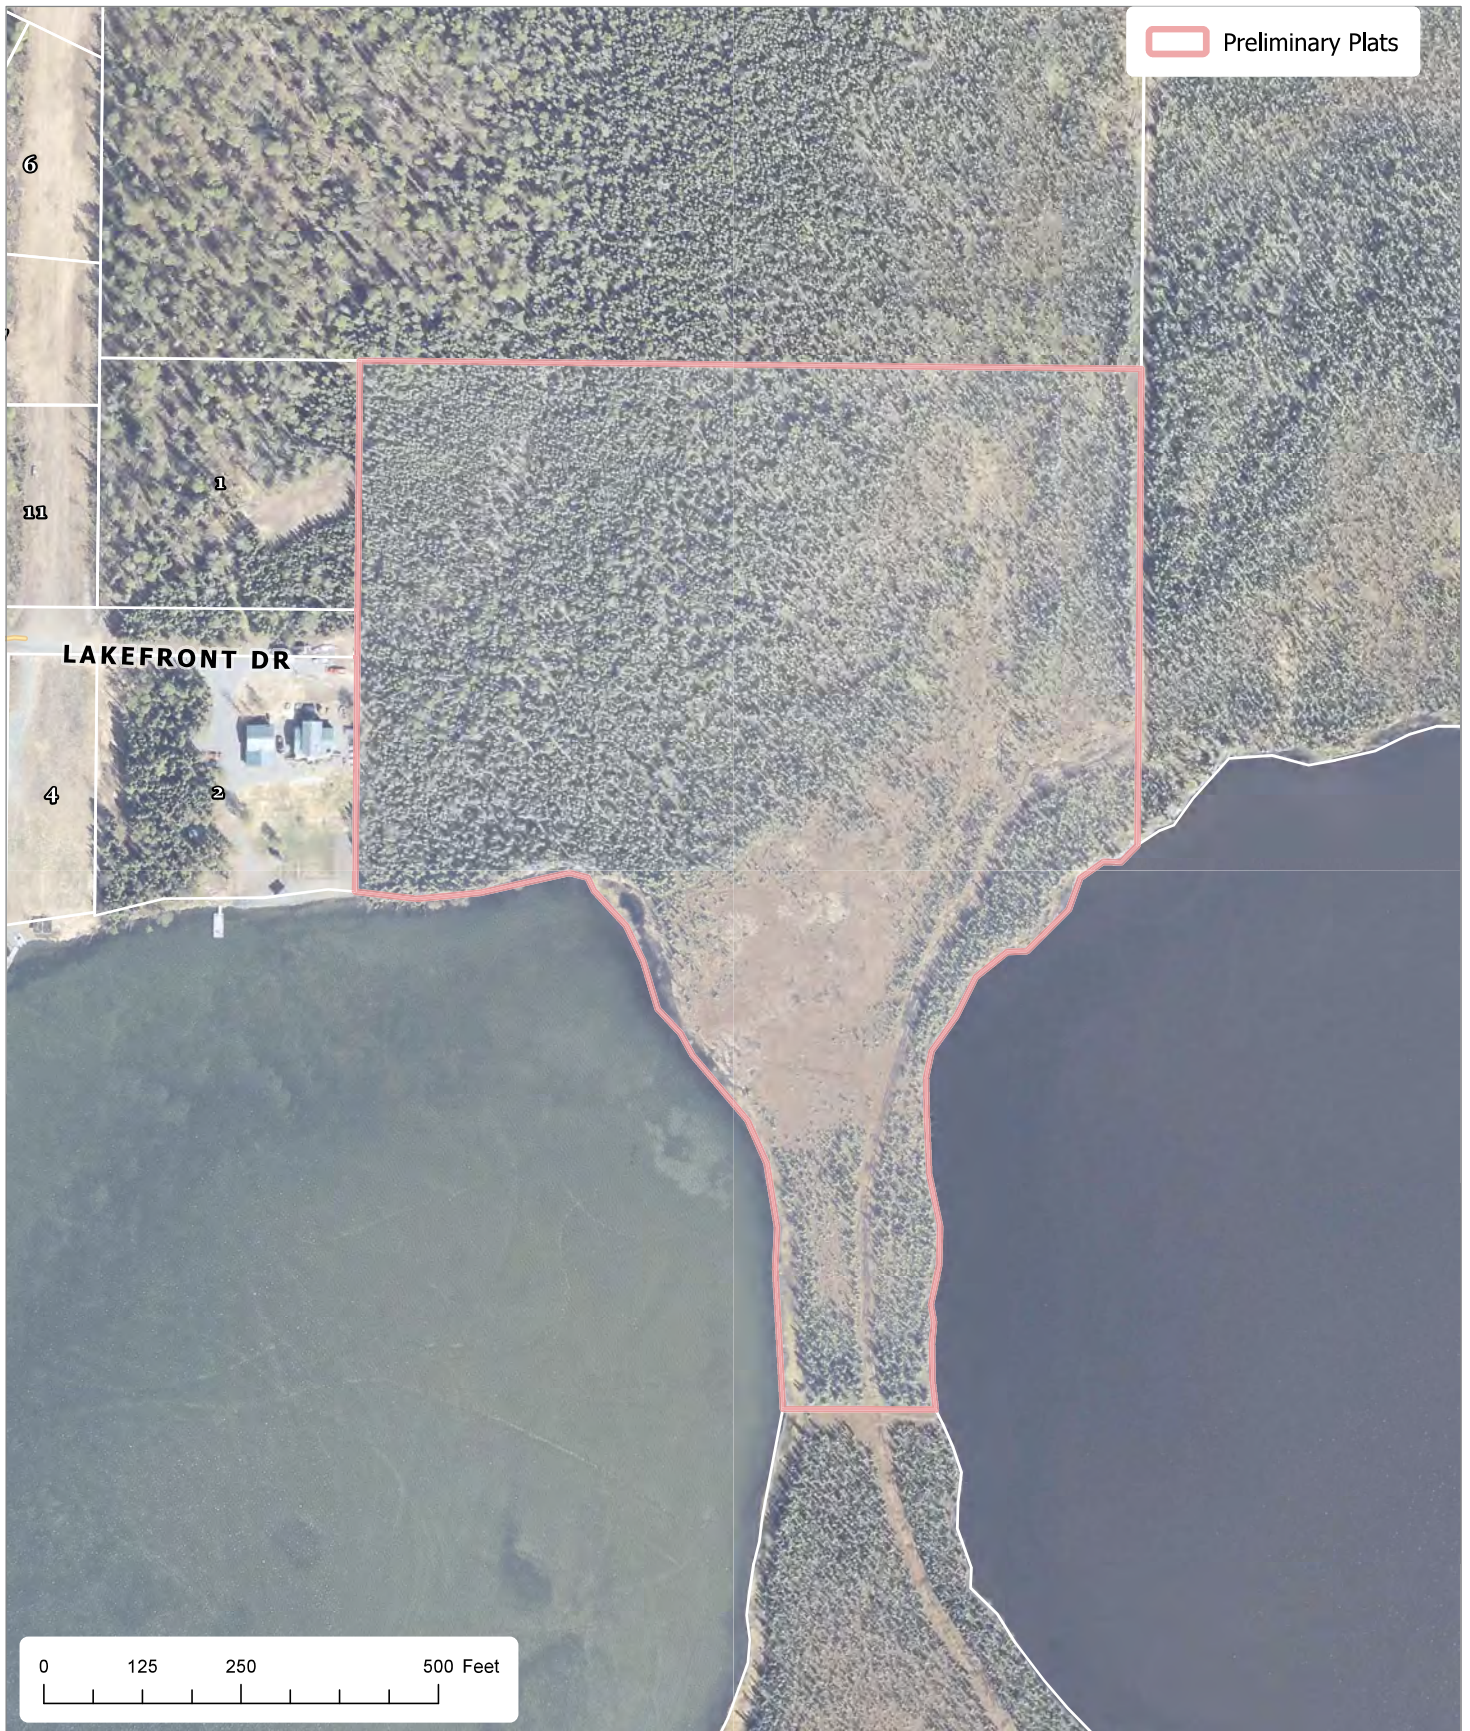
WETLAND BOUNDARY AS IDENTIFIED BY ABR INC.

1. THIS IS A PRELIMINARY PLAT, PARCEL DIMENSIONS ARE PER RECORD PLATS. NO FIELD SURVEY HAS BEEN COMPLETED.
2. STREET RIGHT-OF-WAY WIDTHS SHOWN TO THE NEAREST FOOT REPRESENT ACTUAL DIMENSIONS TO THE NEAREST HUNDRETH OF A FOOT (E.G. 30'-30.00').
3. RIGHT-OF-WAY DEDICATED THIS PLAT:
 - A. AN EXTENSION OF THE EXISTING ROW OF WAY FOR LAKEFRONT DRIVE INTO THE EXISTING GOVERNMENT LOT 5

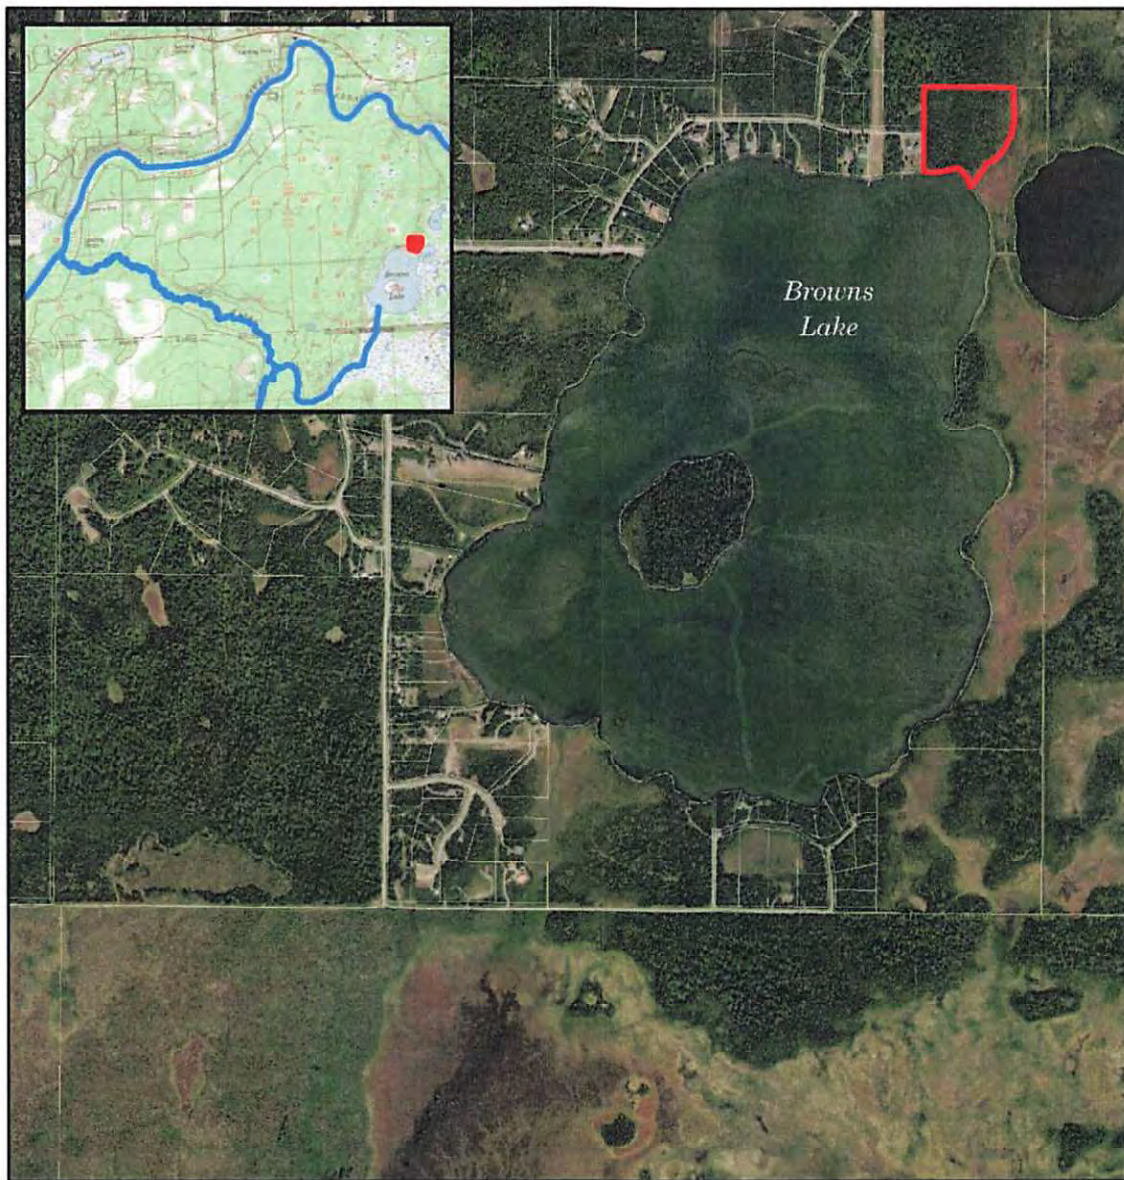
Wetland boundaries were identified in the field and were then delineated on-screen using ArcGIS software overlaid on the imagery for the parcel study area. As noted above, the primary imagery used for mapping was high-resolution (0.5-meter pixel resolution) satellite imagery obtained 25 June 2019 and available as part of ESRI's World Imagery basemap.

Study Area

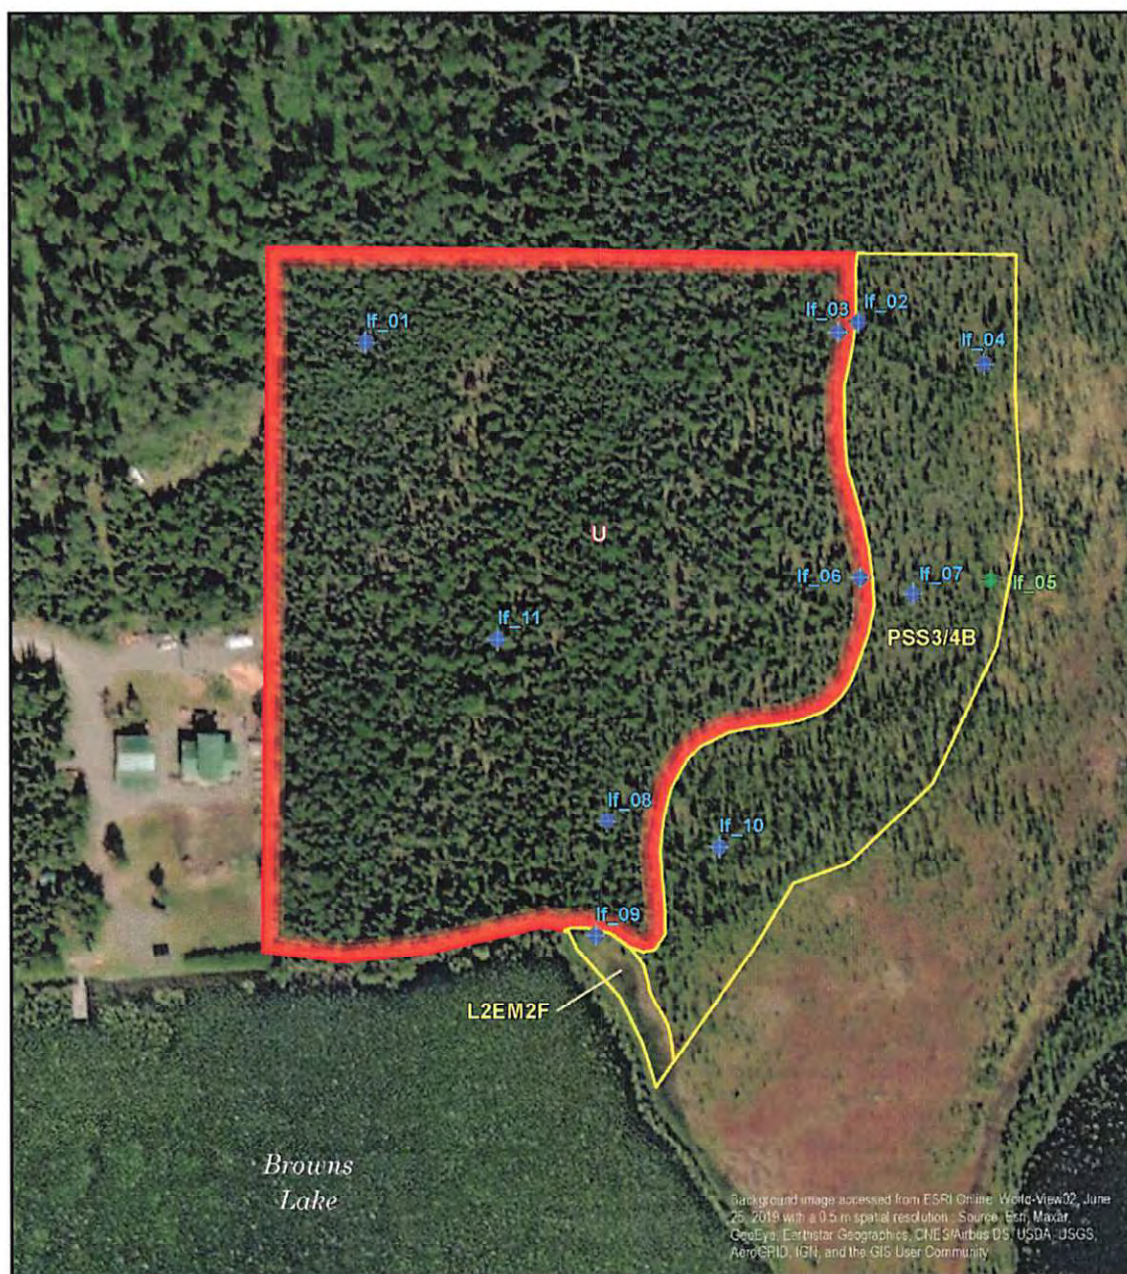
Palustrine Seasonally Saturated Broad-leaved/Needle-leaved Evergreen Scrub-Shrub (PSS3/4B) wetlands were documented throughout the eastern half of the study area (Figure 2). Encompassing 2.6 acres (24.4% of the study area, Table 2), PSS3/4B wetlands are characterized by the wetland determination plots If_02, If_04, If_07, and If_10 (Appendix A), and the map verification plot If_05 (Appendix B). The PSS3/4B wetlands in the study area are dominated by *Picea mariana* (black spruce, FACW) trees and saplings; the shrubs *Rhododendron groenlandicum* (rusty Labrador tea, FAC), *Empetrum nigrum* (black crowberry, FAC), *Vaccinium uliginosum* (alpine blueberry, FAC), and *V. vitis-idaea* (northern mountain cranberry, FAC); and the herbs *Equisetum arvense* (field horsetail, FAC) and *Rubus chamaemorus* (cloudberry, FACW). The PSS3/4B wetlands typically had thick surface organic layers, meeting hydric soil indicators Histosol or Histel (A1) and/or Histic Epipedon (A2). Soils were saturated at or near the surface, with all plots in PSS3/4B wetlands meeting the wetland hydrology indicators High Water Table (A2) and Saturation (A3).

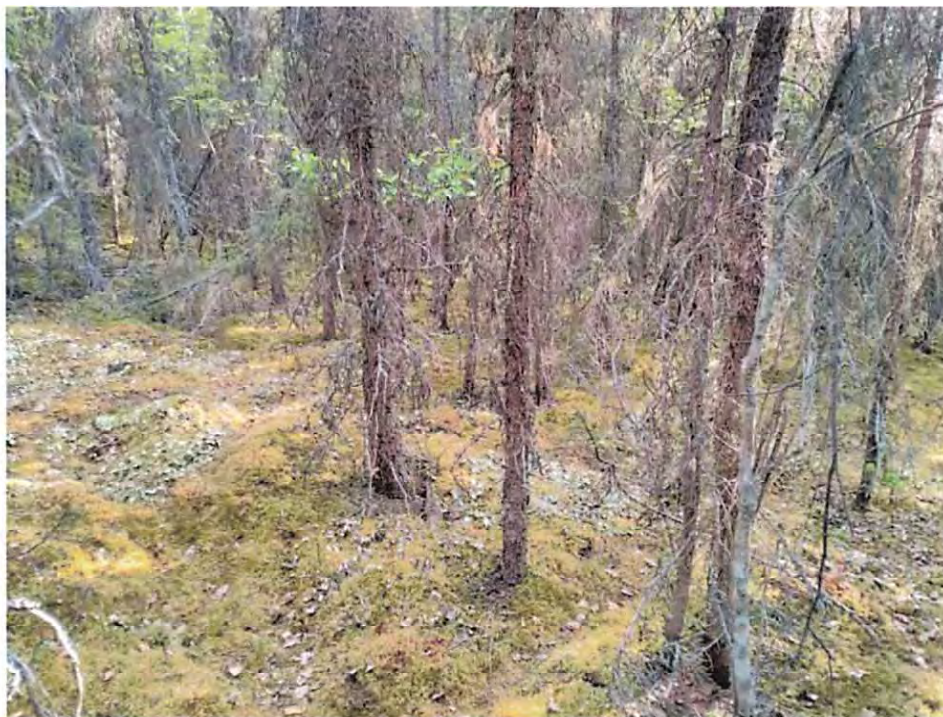
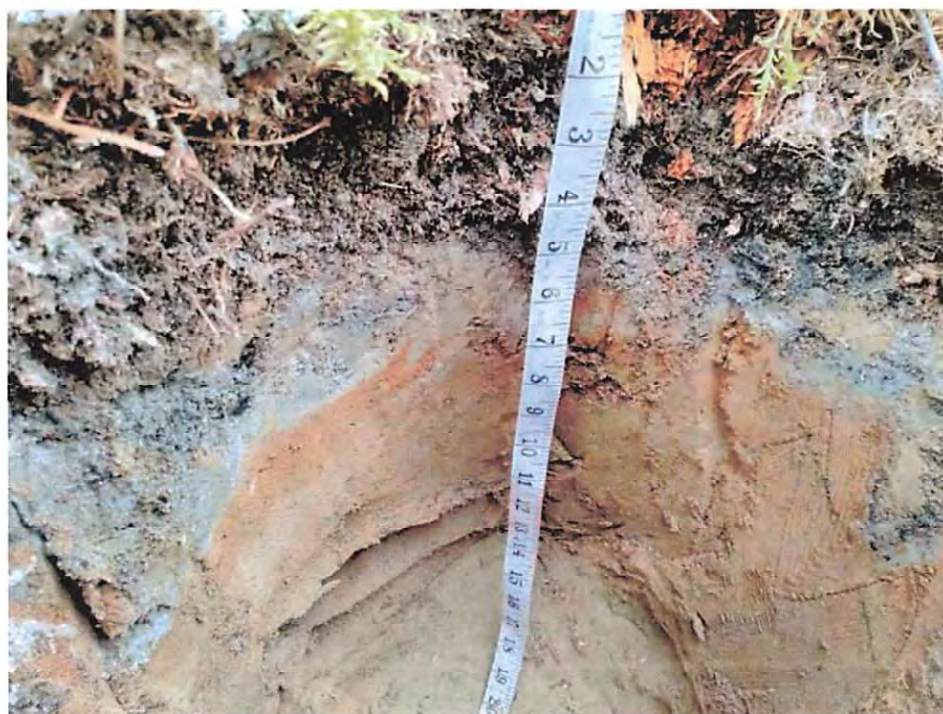
Sampling Point: lf_01

NWI classification: U

Hydric Soil Indicators: None

Wetland Hydrology Indicators: None

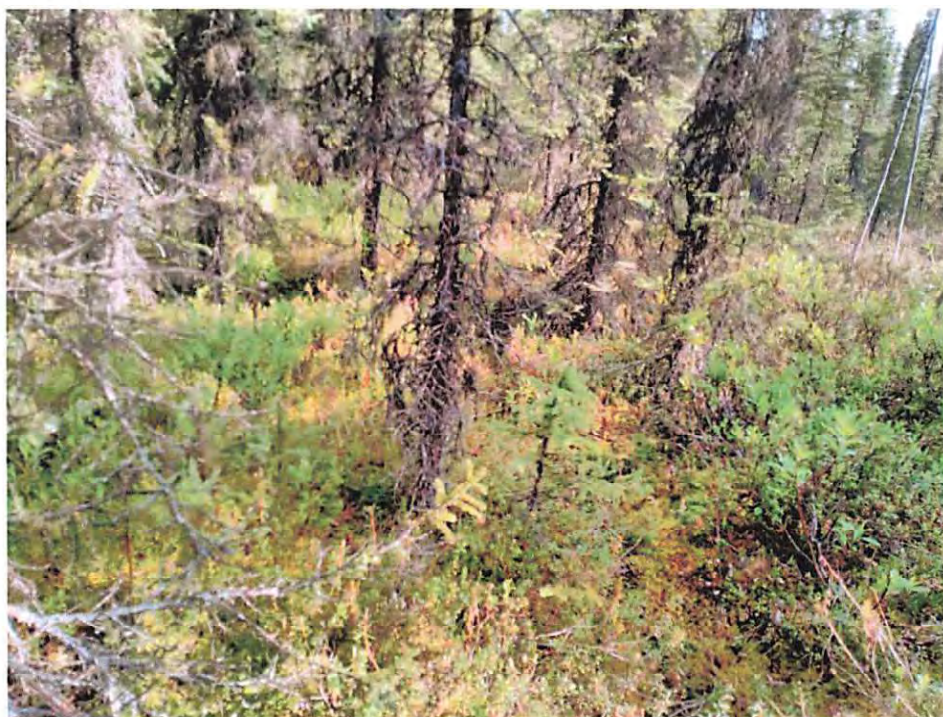
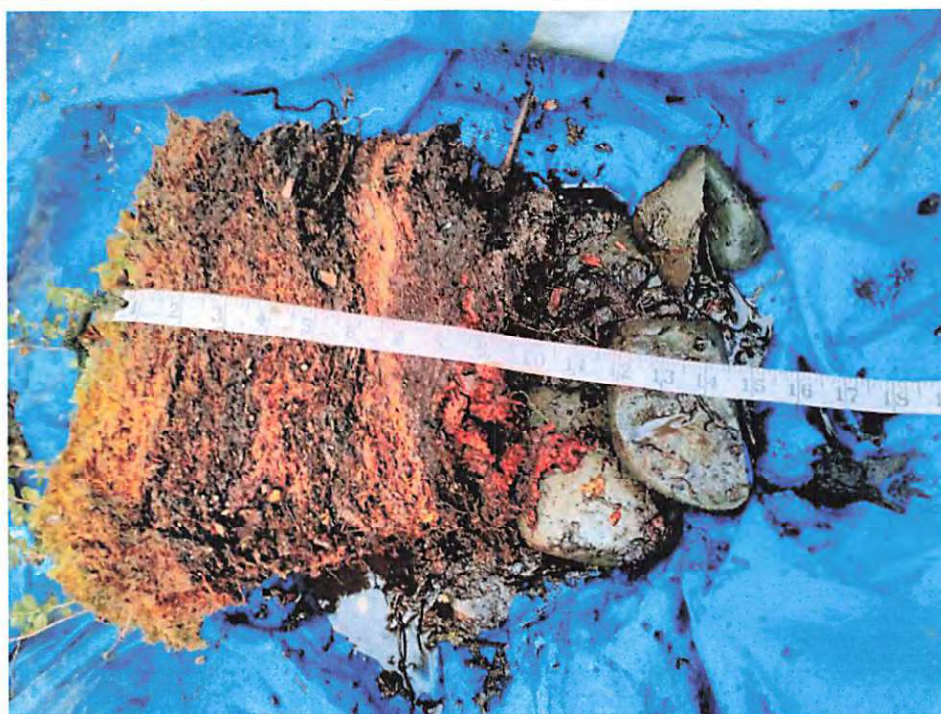
Sampling Point: lf_02
NWI classification: PSS3/4B

Hydric Soil Indicators: Histic Epipedon (A2), Histosol or Histel (A1)
Wetland Hydrology Indicators: Saturation (A3), High Water Table (A2), FAC-Neutral Test (D5)

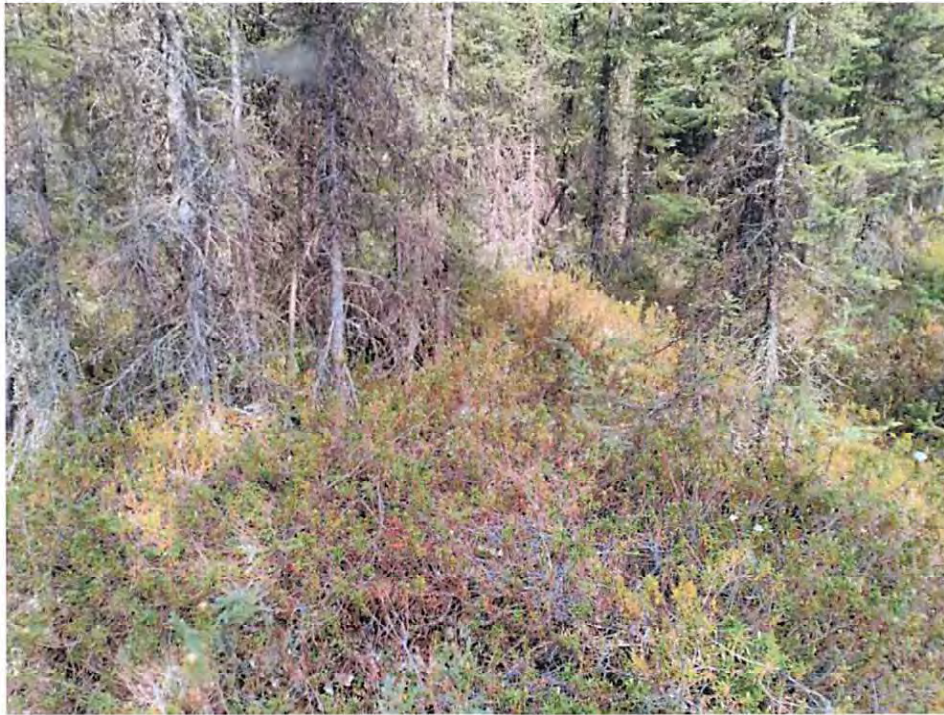
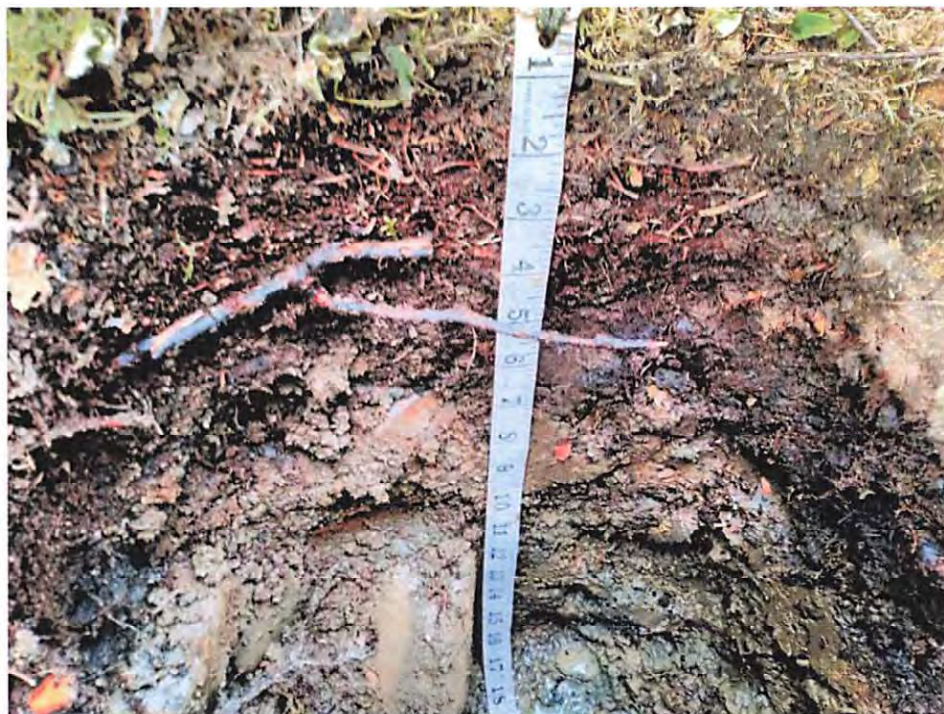
Sampling Point: lf_03
NWI classification: U

Remarks: Saturated layer at 14 to 16 inches underlain by a drier layer suggestive of percolating water from precip, no restrictive layer observed.

Hydric Soil Indicators: None
Wetland Hydrology Indicators: None

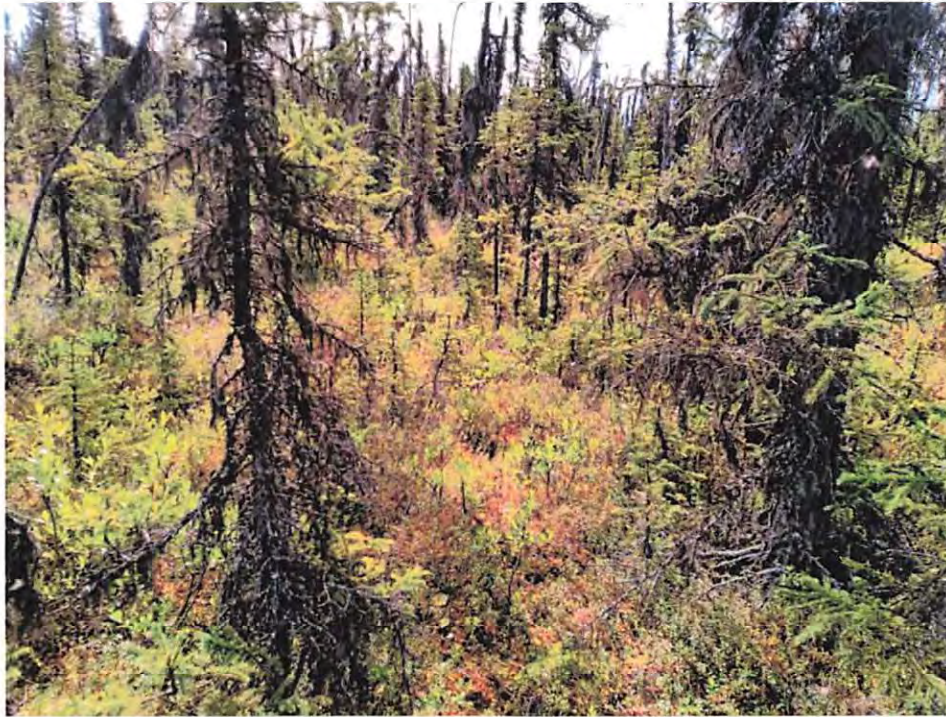
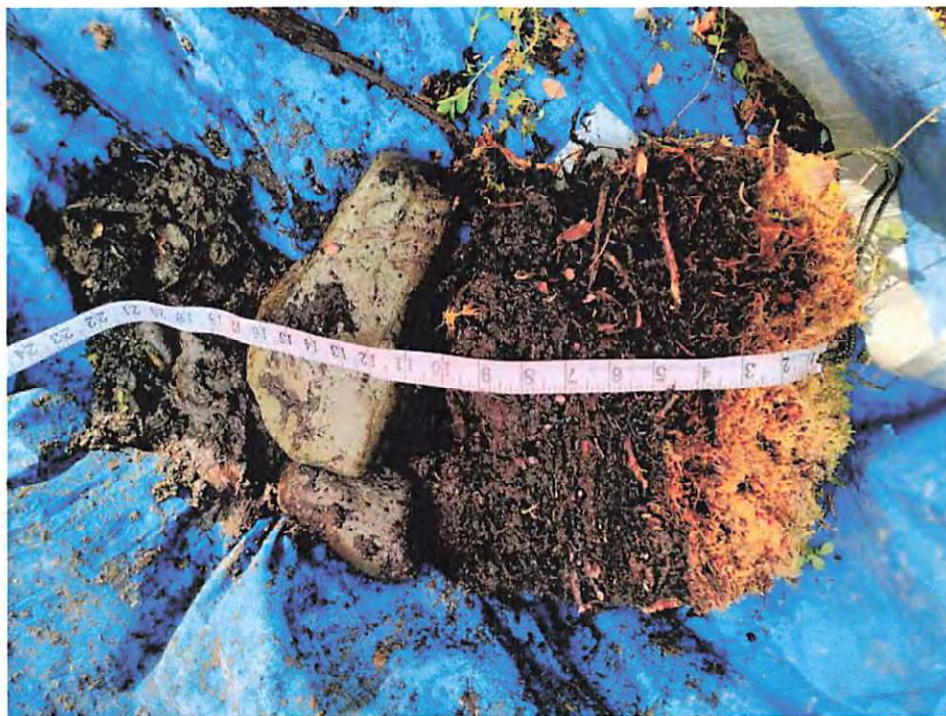
Sampling Point: lf_04
NWI classification: PSS3/4B

Hydric Soil Indicators: Histosol or Histel (A1), Histic Epipedon (A2)
Wetland Hydrology Indicators: Saturation (A3), High Water Table (A2)

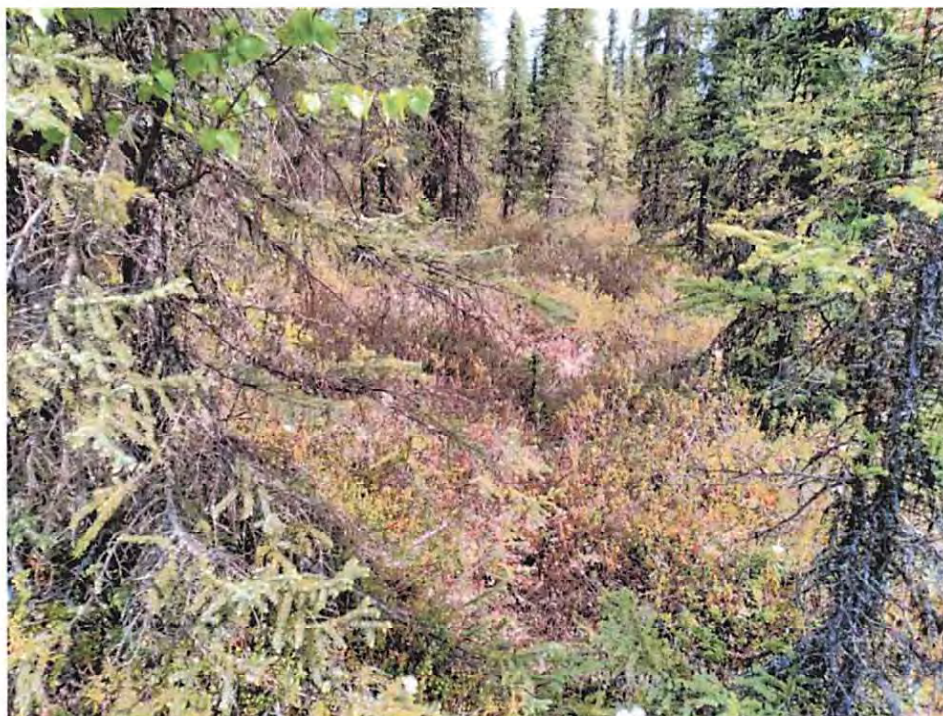
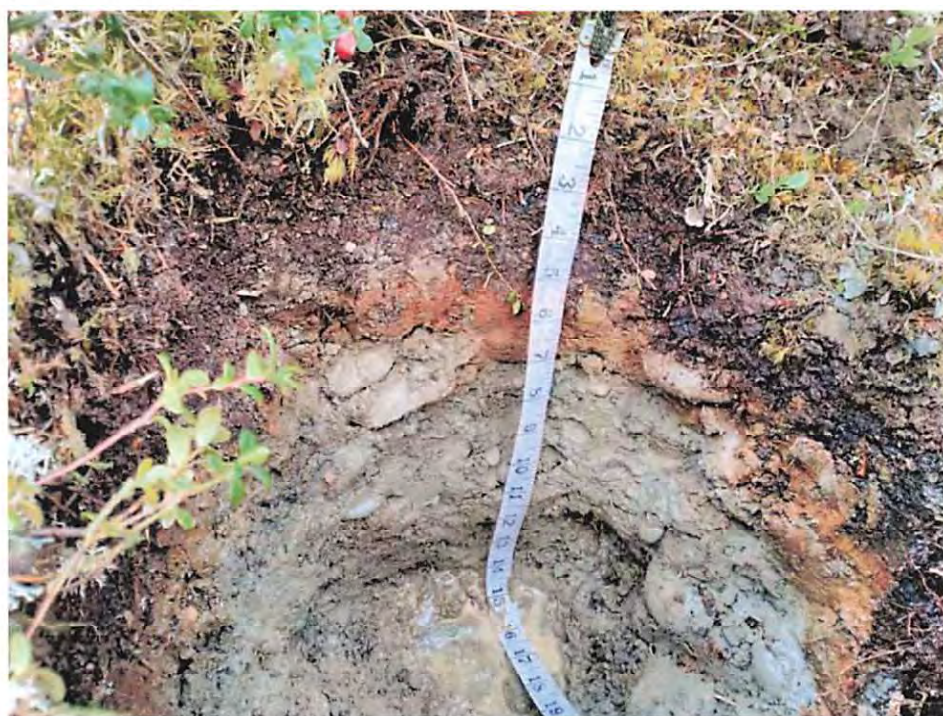
Sampling Point: lf_06
NWI classification: U

Remarks: Saturated layer at the top of the mineral layer (5 inches) weeping water into pit but underlying layers are dry with no restrictive layer suggesting precip driven feature

Hydric Soil Indicators: None
Wetland Hydrology Indicators: None

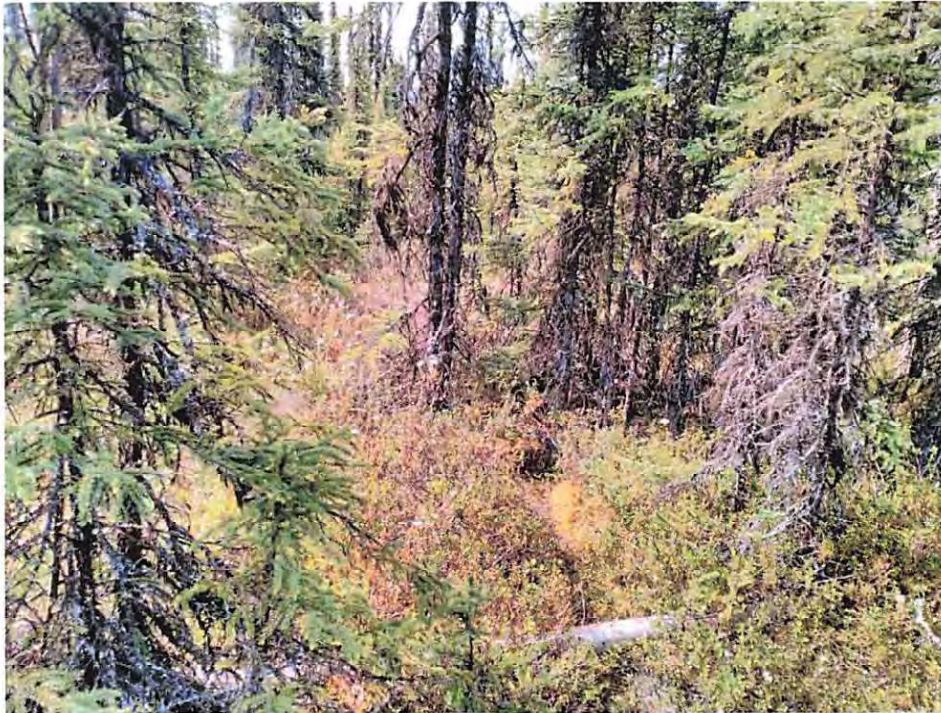
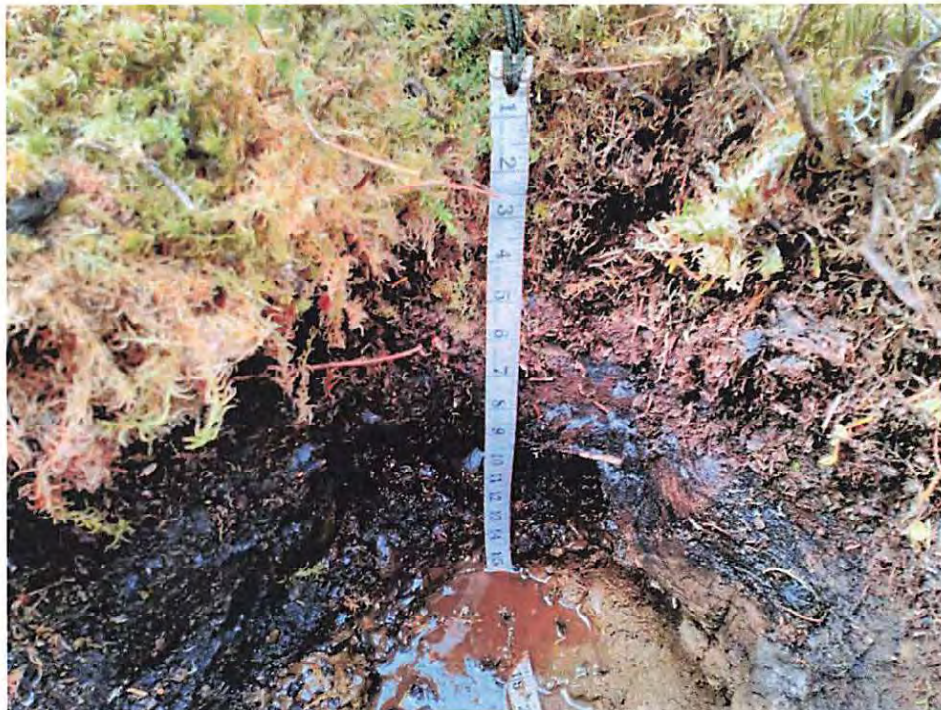
Sampling Point: lf_07
NWI classification: PSS3/4B

Remarks: Ice rich frost layer at organic mineral interface. Frozen from 6 to 9. Soils do not meet low chroma criteria for histtic epipedon or any other hydric soil indicator, negative rxn to alpha, alpha-dipyridol. Site has very strong hydro and veg indicators. Assume that pit was dug exactly on the wetland boundary.

Hydric Soil Indicators: Other (explain in remarks)
Wetland Hydrology Indicators: High Water Table (A2), Saturation (A3)

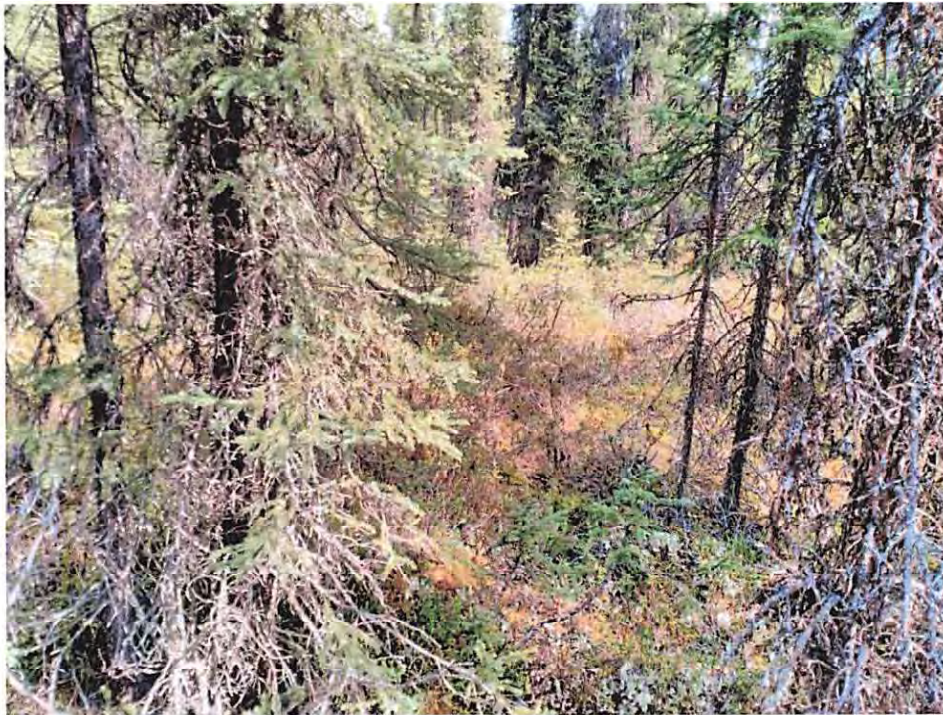
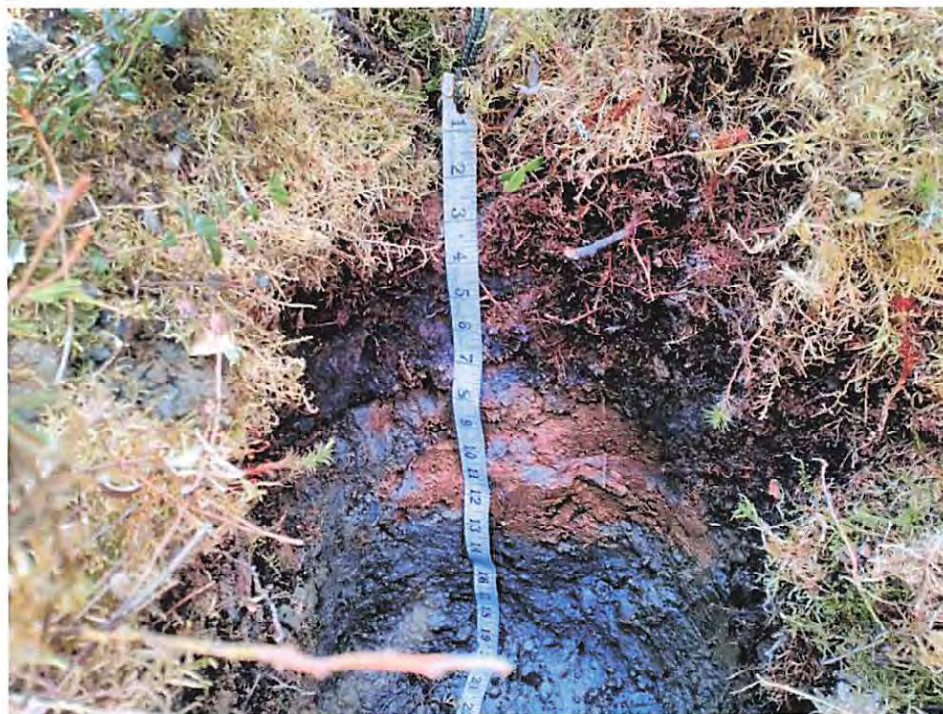
Sampling Point: lf_08
NWI classification: U

Remarks: No primary indicators saturated below 12

Hydric Soil Indicators: None
Wetland Hydrology Indicators: FAC-Neutral Test (D5)

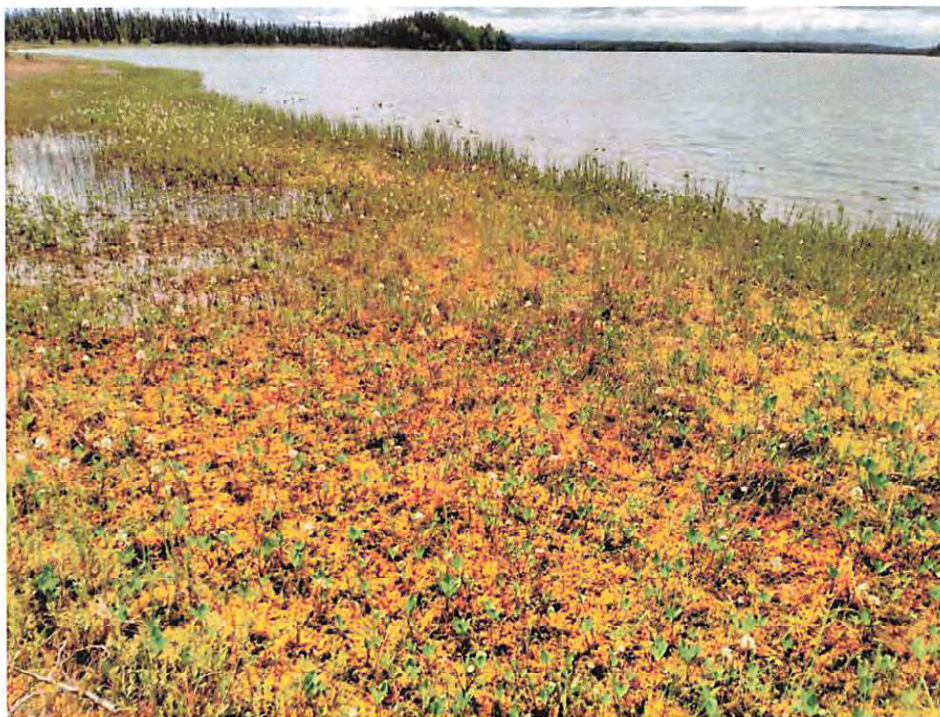
Sampling Point: lf_09
NWI classification: L2EM2F

Hydric Soil Indicators: Other (explain in remarks)

Wetland Hydrology Indicators: FAC-Neutral Test (D5), Geomorphic Position (D2), Saturation (A3), High Water Table (A2)

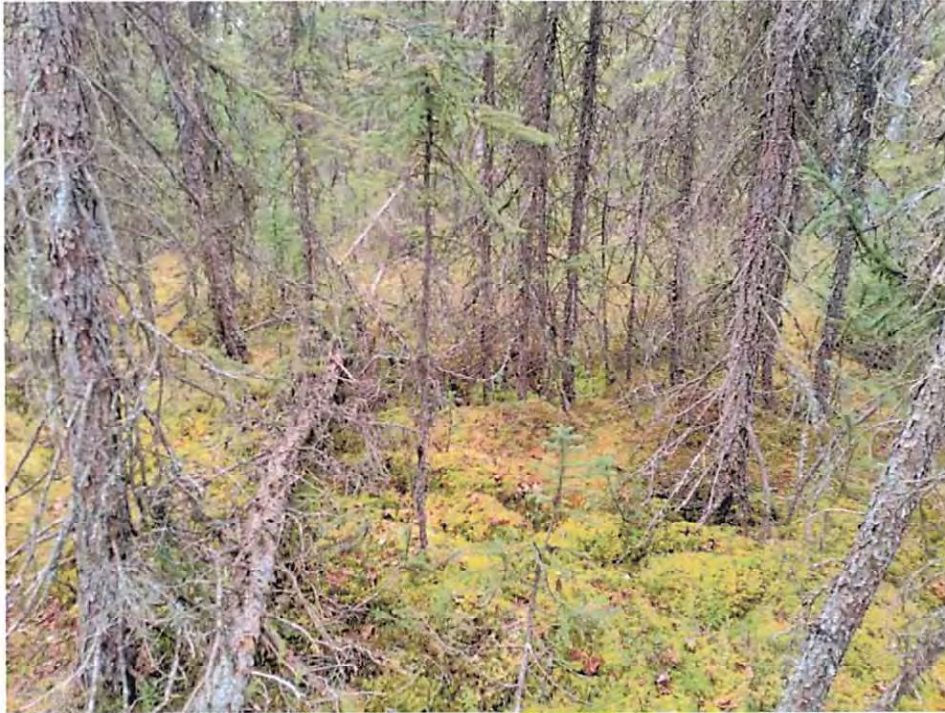
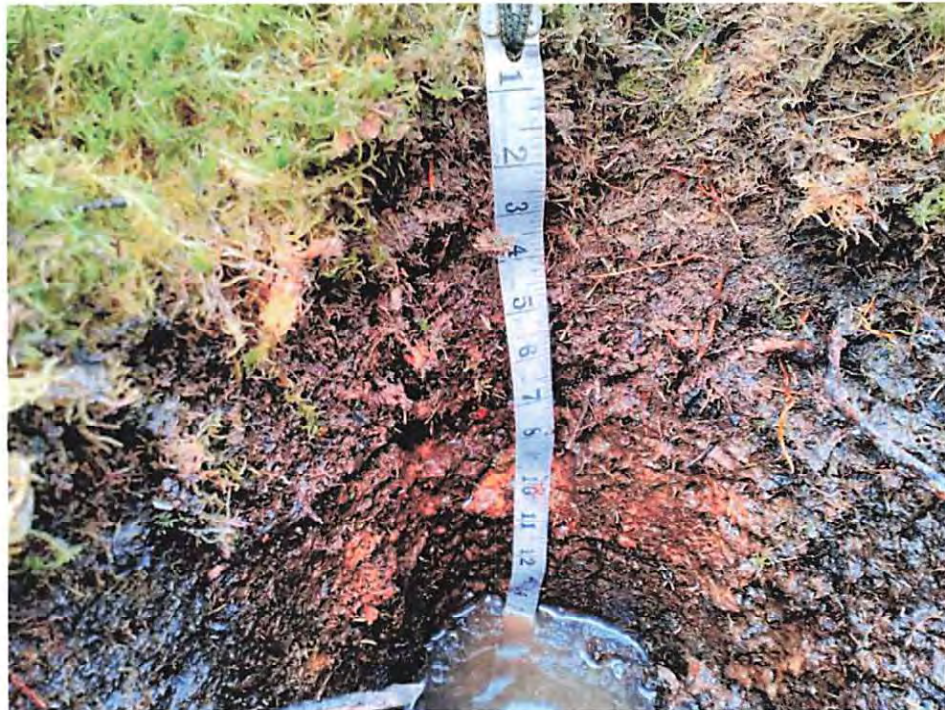
Sampling Point: lf_10
NWI classification: PSS3/4B

Hydric Soil Indicators: Histosol or Histel (A1), Histic Epipedon (A2)
Wetland Hydrology Indicators: FAC-Neutral Test (D5), Saturation (A3), High Water Table (A2)

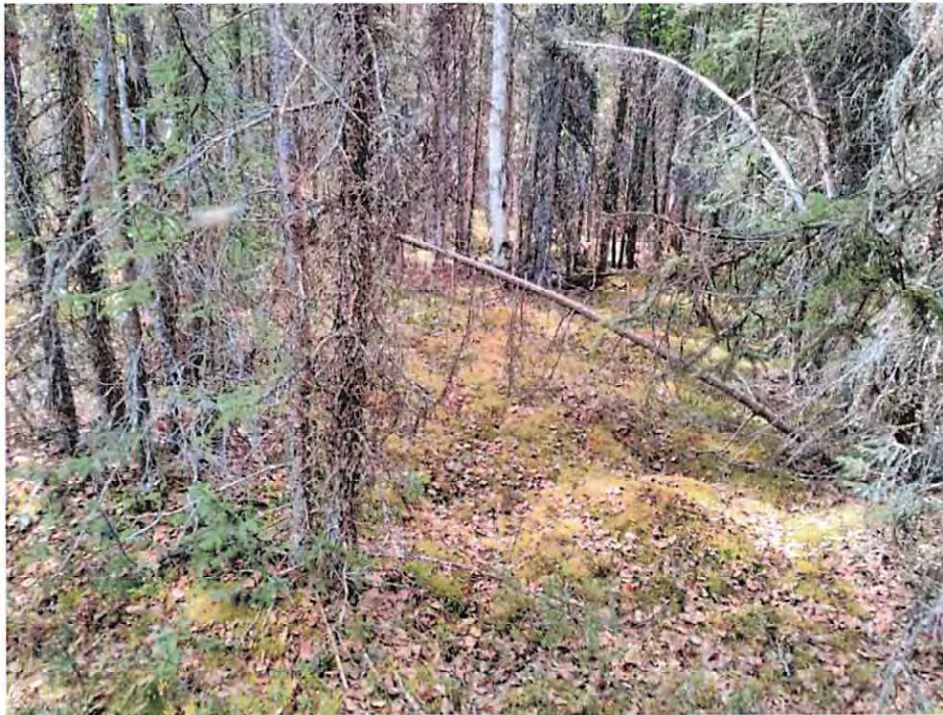
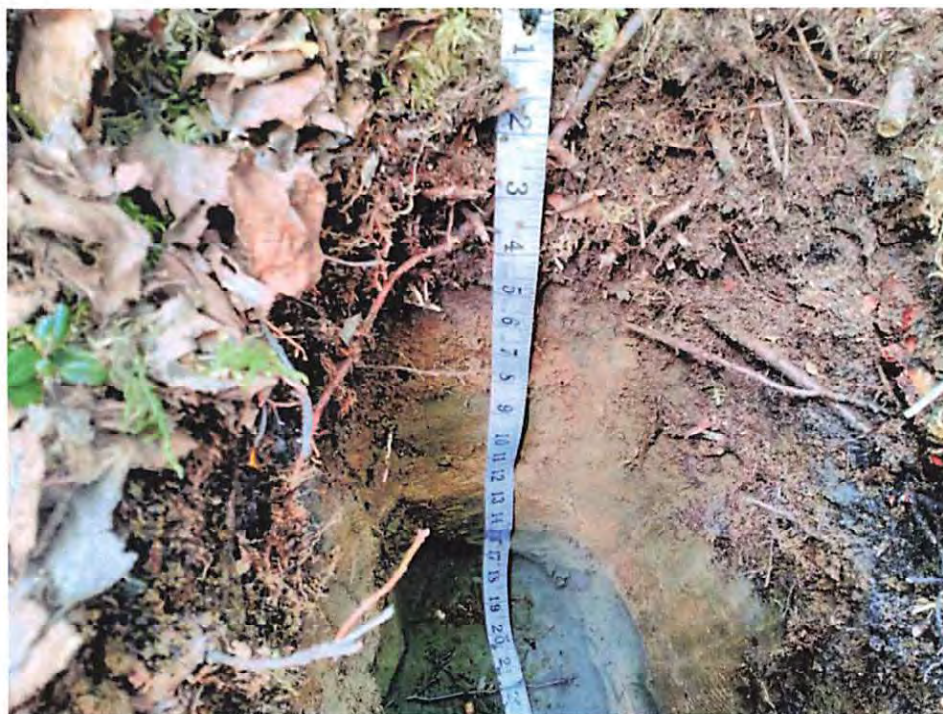
Sampling Point: lf_11
NWI classification: U

Remarks: No hydrology indicators observed

Hydric Soil Indicators: None
Wetland Hydrology Indicators: FAC-Neutral Test (D5)

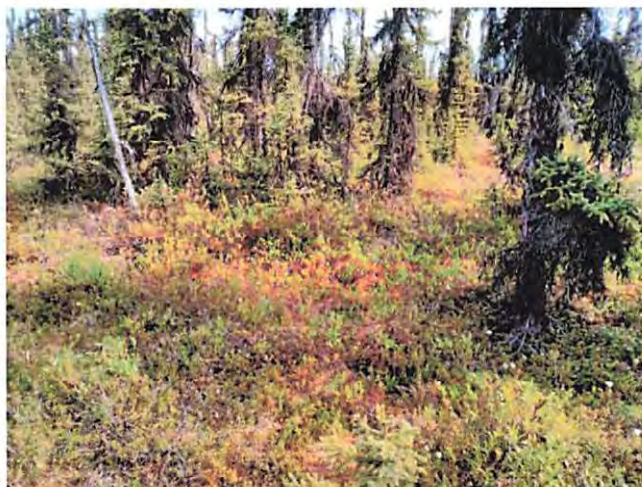
Sampling Point: lf_05

Species: *Picea mariana*, *Vaccinium uliginosum*, *Vaccinium vitis-idaea*, *Salix pulchra*, *Rhododendron groenlandicum*

Notes: Located on outer boundary of mapping area within previously mapped wetlands. Significant sphagnum cover and saturation at surface.

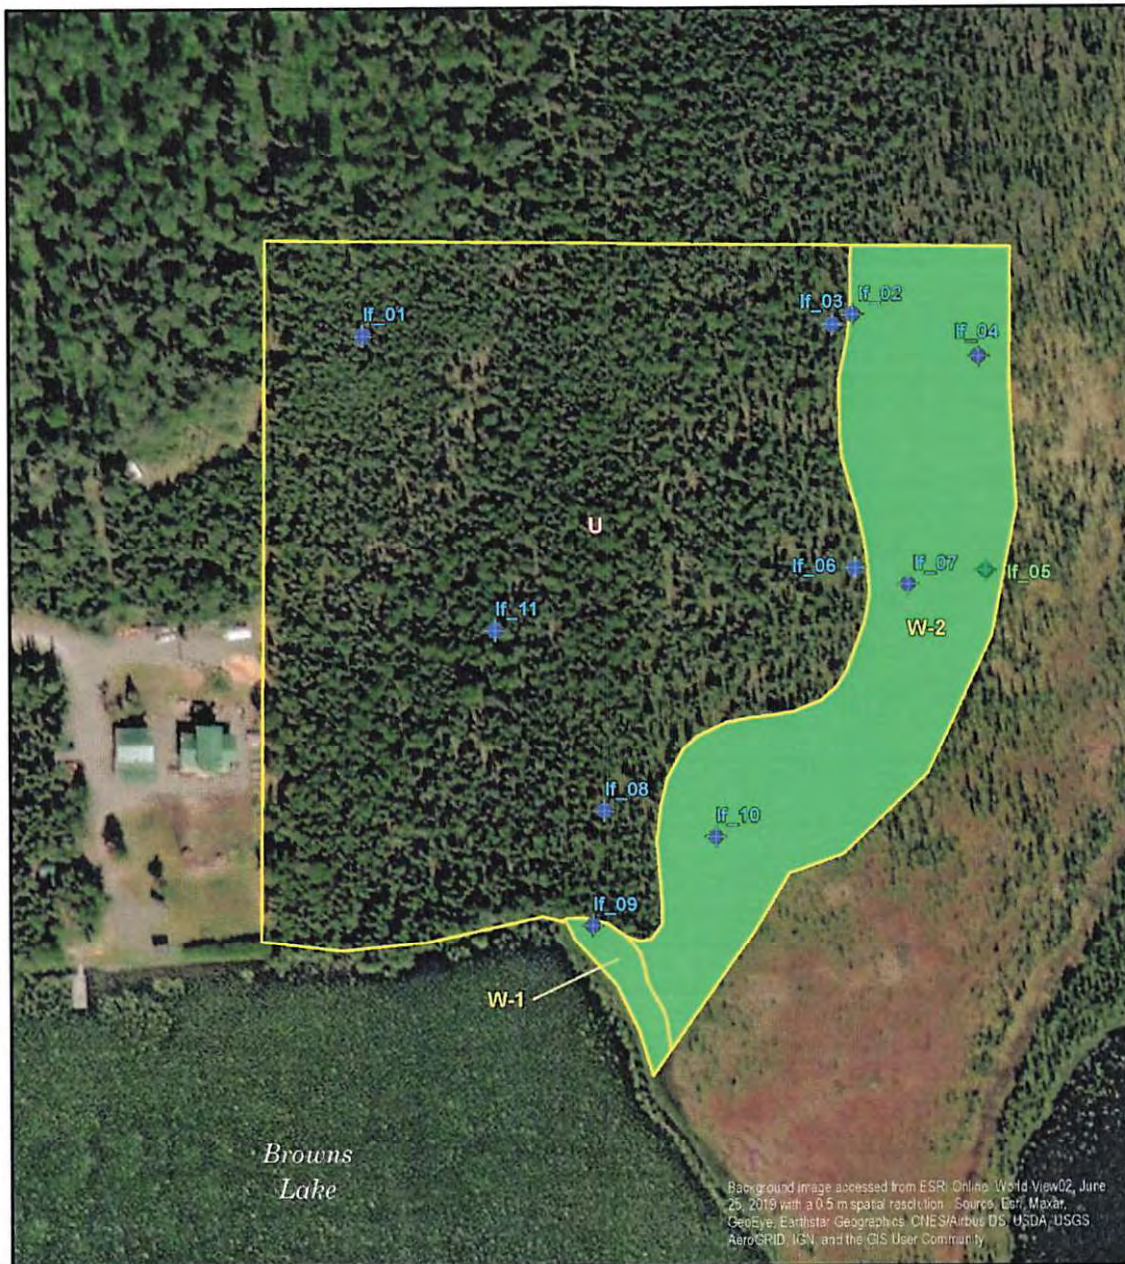
Appendix C. Characteristics of wetlands and waters mapped in the Lakefront Drive wetlands study area, Alaska, 2021

- (a)(4) wetlands adjacent to jurisdictional waters
- Non-jurisdictional (uplands)
- **W-2** Mapped Wetlands and Waters²
