WINCE – CORTHELL – BRYSON
Consulting Engineers
Box 1041 Kenai, Alaska 99611
Phone 907-283-4672 Fax 907-283-4676
email: mblanning@wcbalaska.com

December 17, 2021

Subject: Slope Instability Investigation in Cooper Landing

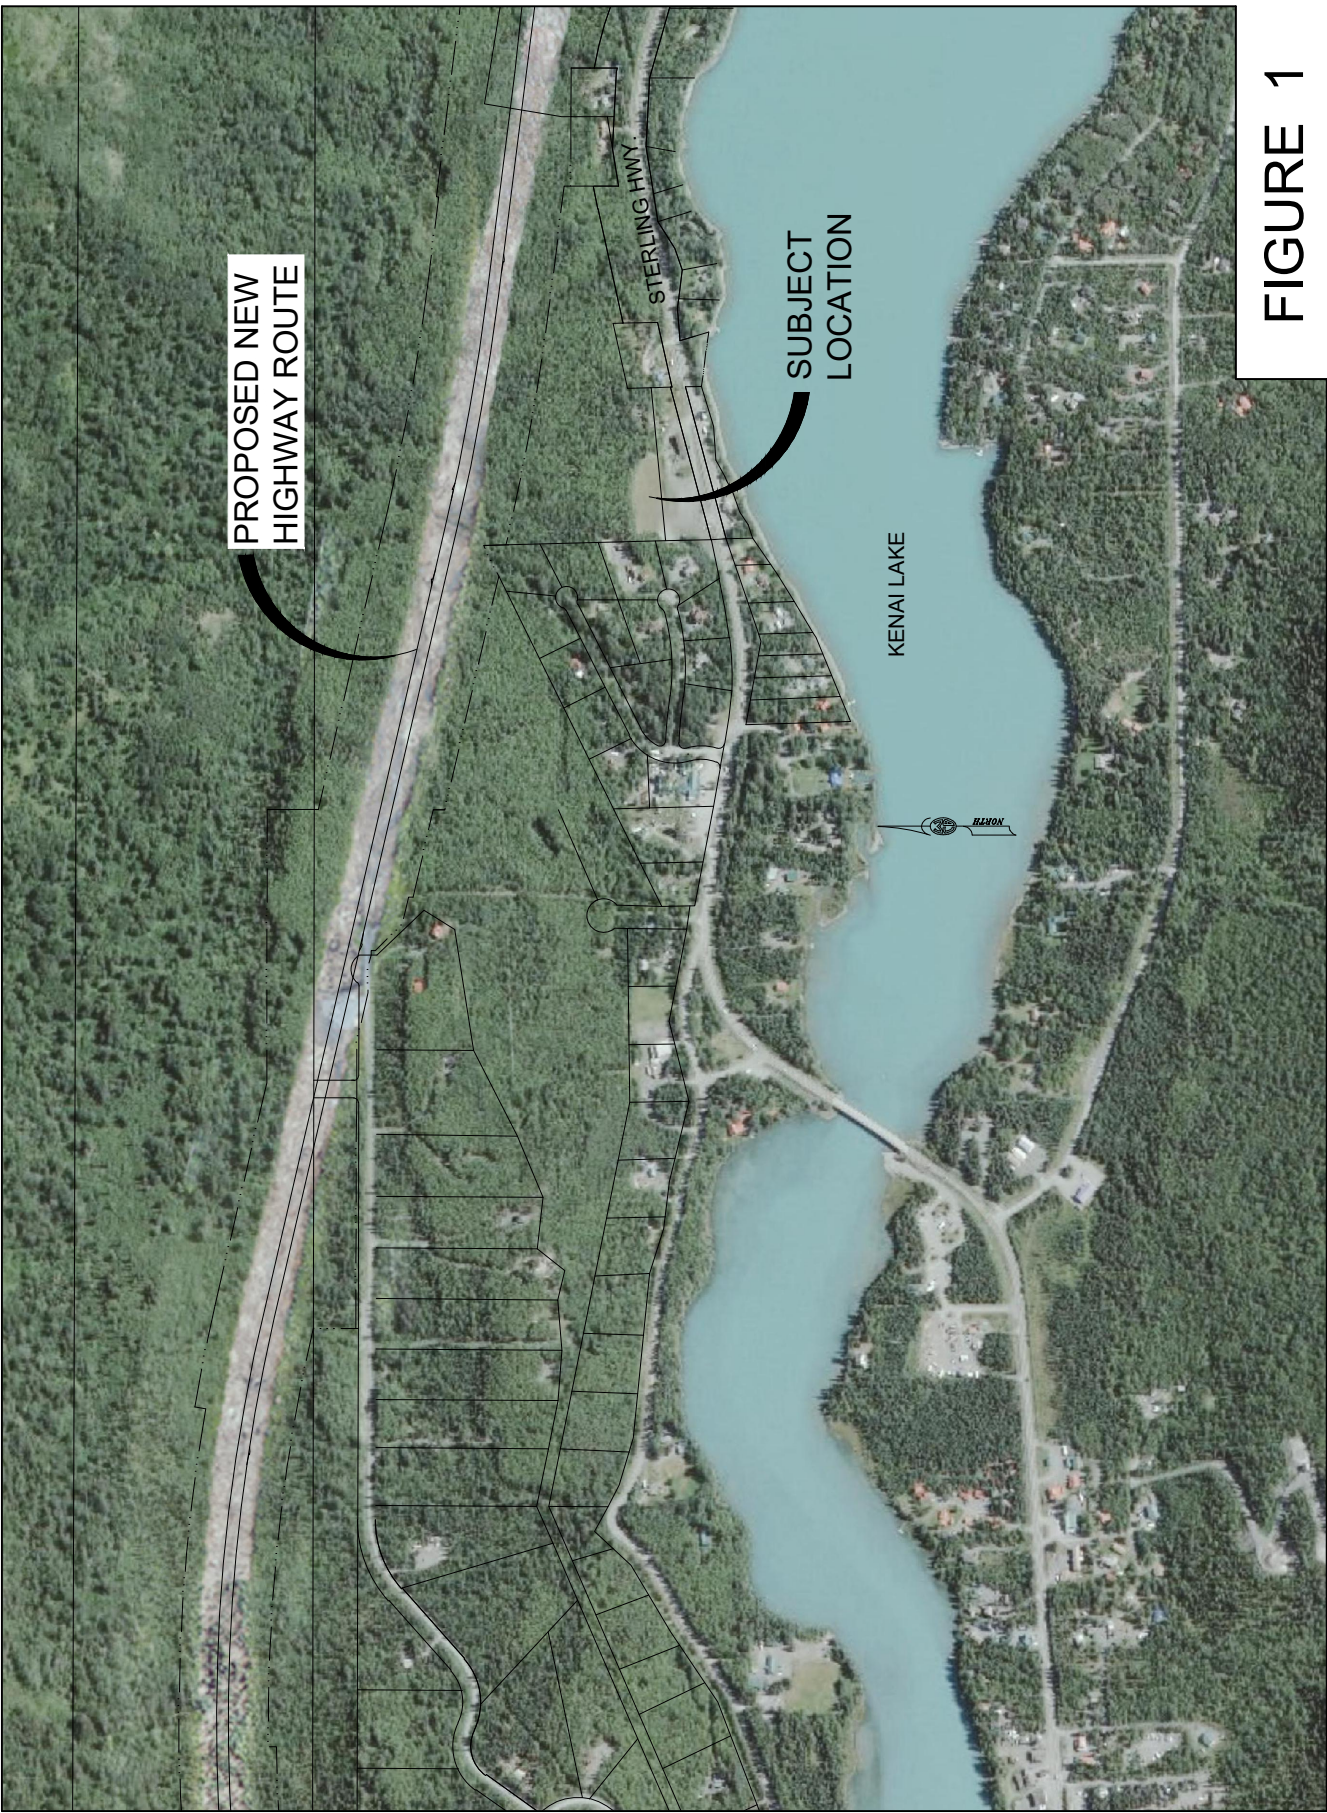
FIGURE 1

The slope in question is located in Cooper Landing, Alaska on Tract A, ASLS 2003-2, SW2005-10 within Section 27, T5N, R3W, Seward Meridian, see attached Figures 1 and 2. The property is owned by the Kenai Peninsula Borough (KPB).
