**US Army Corps  
of Engineers®**

Technical Report

# Japanese Creek Flood Risk Reduction Seward, Alaska

September 2021

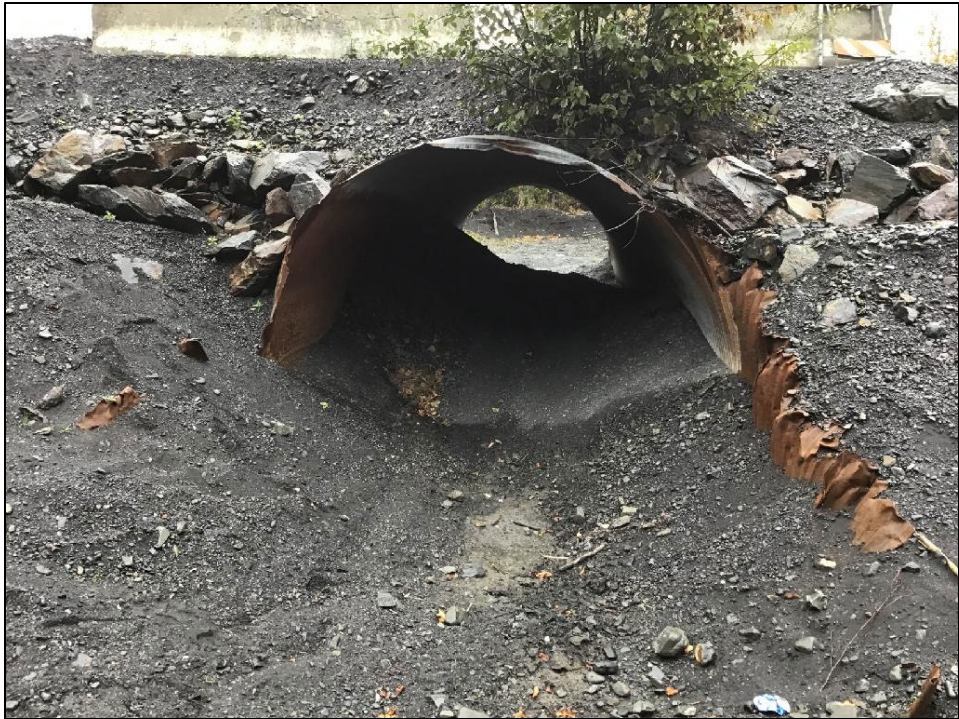
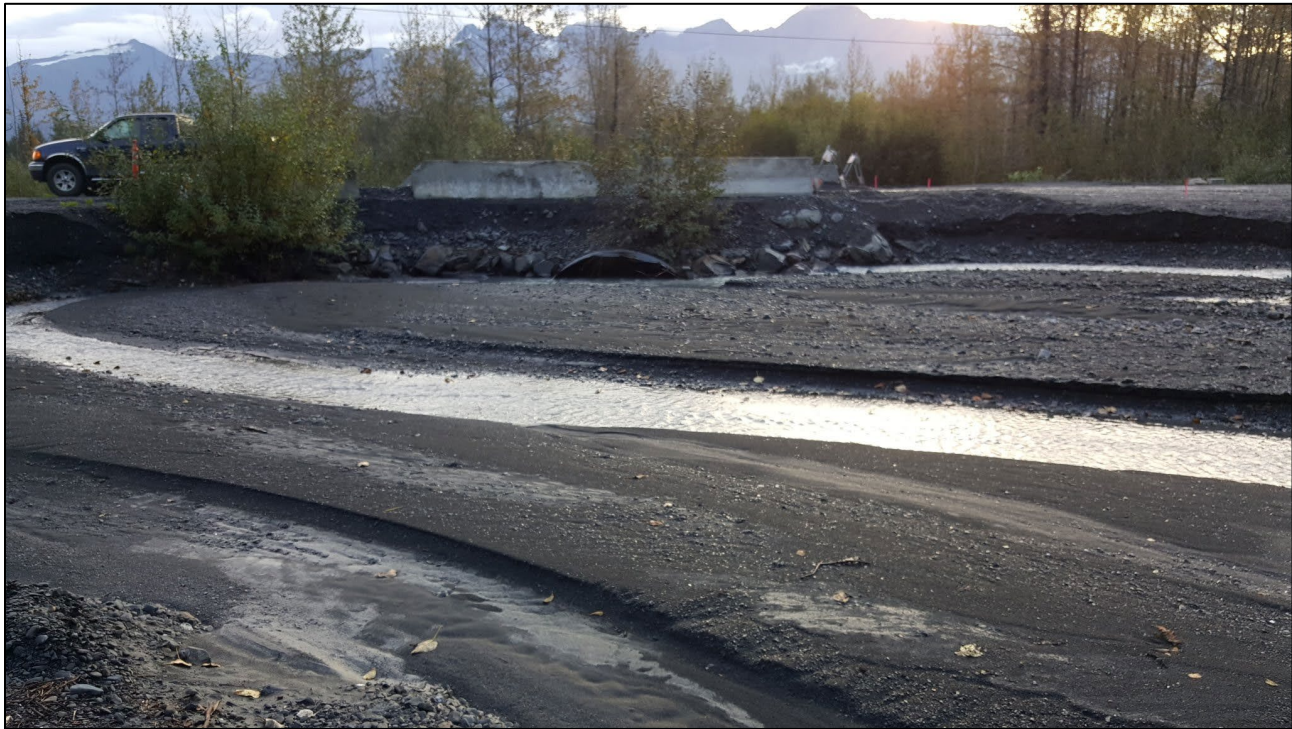
Figure 5. Main 12' culvert under Dieckgraeff Road.

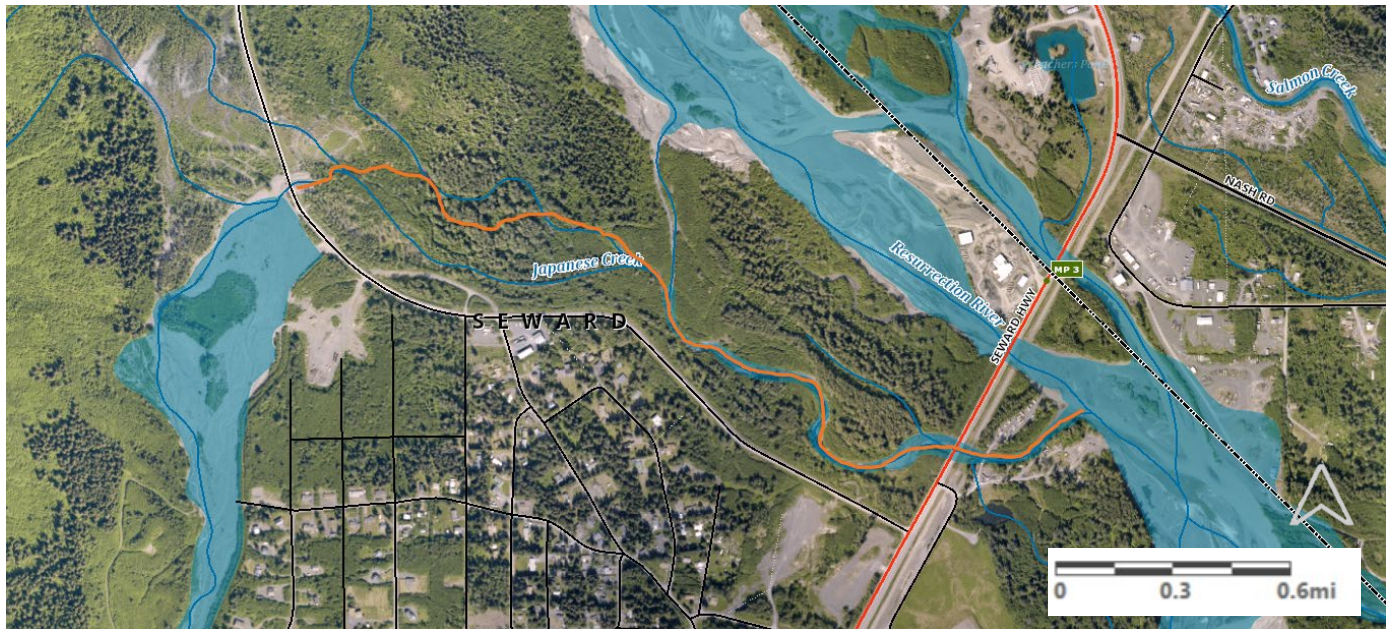
Figure 24. Downstream dredging channel location (orange).

Second iteration hydraulic analysis focused on the downstream channelization (dredging) alternative (2a). This alternative included excavating and lining a channel with rock as shown in Figure 23 along the alignment shown in Figure 24. The channel capacity would be approximately 1% percent chance exceedance, or a 100-year flood. The dredging channel location follows the existing channel as closely as possible and could improve conveyance of sediment to the Resurrection River.
